The Gdynia Railway Station Restoration Project¹

Anna Kriegseisen

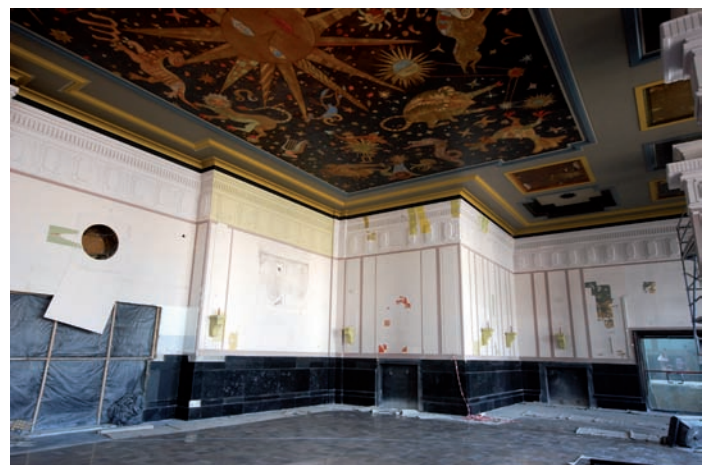
1. Restaurant interior prior to restoration, exposed samples. Photo by A. Kriegseisen

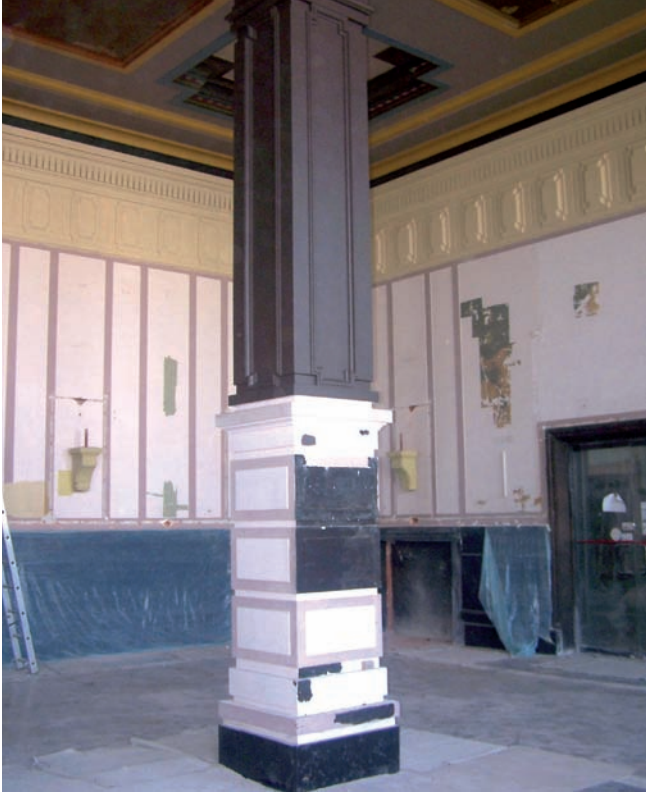
2. Exposed samples of the wooden facing and a colouring test on a column in the restaurant. Photo by A. Kriegseisen

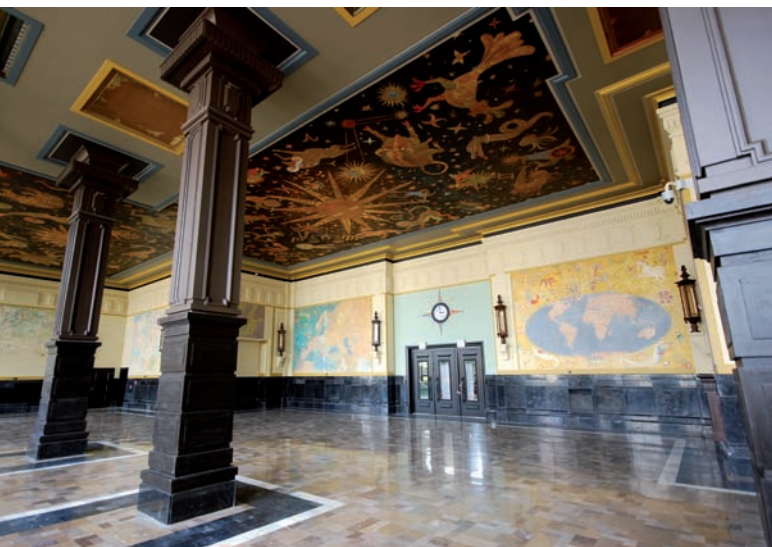
3. Hall after the completion of the restoration project. Photo by A. Kriegseisen

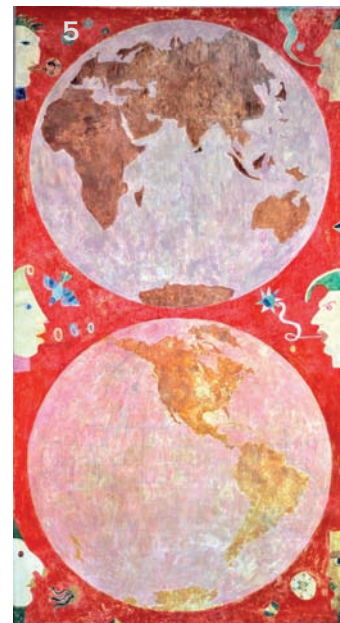
5. Map with personifications of the Anemoi, the Four Winds, after restoration. Photo by A. Kriegseisen

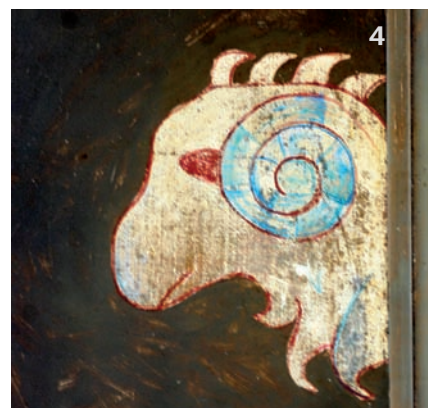
4. Detail of the ceiling coffer ornament after restoration, with visible "aged painting" technique. Photo by A. Kriegseisen

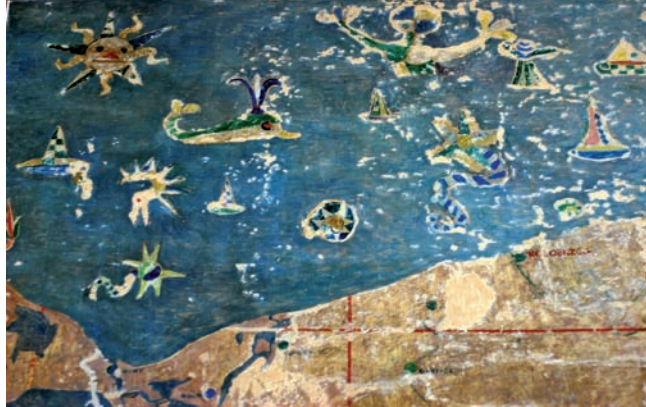
6. Fragment of the coast map after filler application. Photo by A. Kriegseisen

- the painting ensemble on the restaurant walls was uncovered, its loosened fragments bonded; the entire ensemble was reinforced, cleaned, the holes in the base and the foundation were filled in and the painting layer retouched;
- complete restoration of the ceiling paintings in the restaurant;
- complete restoration of the mosaics in the ticket and left luggage halls;
- complete restoration of the wooden décor components: panelling, 24 double doors, the clock in the ticket hall, the lantern casings, radiator casings and faux fireplaces.

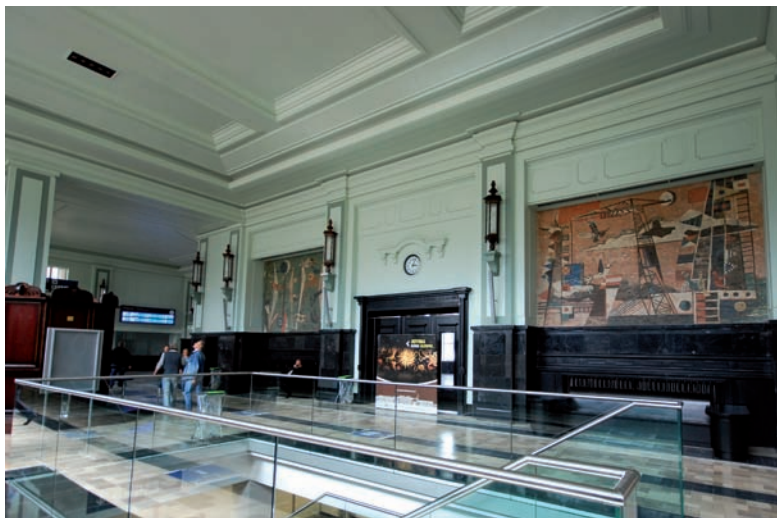
7. Left luggage hall with mosaics. Glazed stairway to the basement storey. Photo by A. Kriegseisen

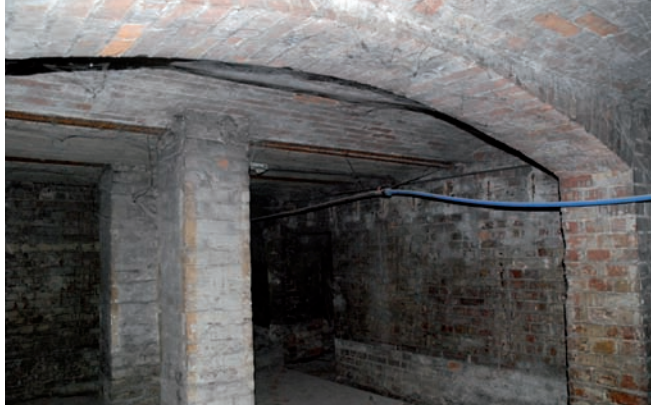
8. Fragment of the old railway station basement, after uncovering. Photo by A. Kriegseisen

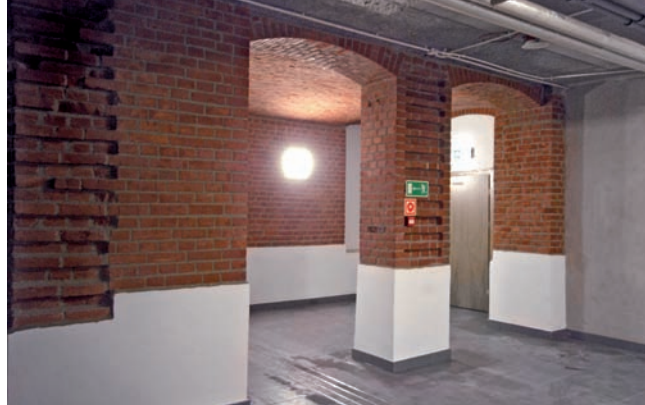
9. Fragment of the old railway station basement, after restoration. Photo by A. Kriegseisen

of the old railway station were uncovered, and a fragment of the arcade wall on the ground floor - also a relic of the 1926 building - was restored;

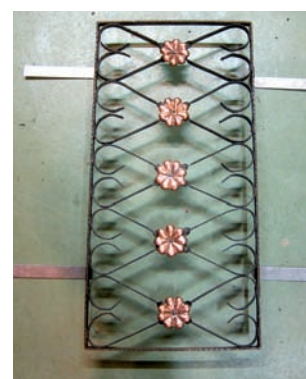
10. Vent grille on the hall ceiling, after restoration. Photo by A. Kriegseisen
