## The Dramatic Beginnings of Modernism in Poland or Kraków's Trouble with *Ferroconcrete*

Waldemar J. Affelt

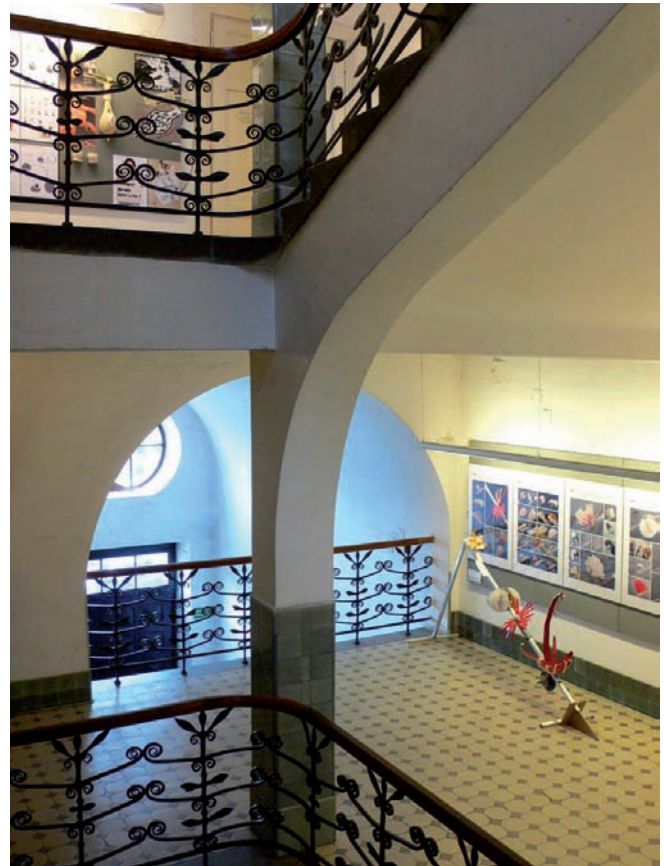
3. Kraków, Academy of Fine Arts Faculty of Industrial Design: the main staircase; ferroconcrete pillar supporting the landing and "softly" transformed into a diagonal beam supporting a flight of stairs. Photo by W. Affelt

Today, a hundred years after the event, one should not fail to step into the Kraków Academy of Fine Arts Department of Industrial Design at 9 Smoleńsk St. and marvel at what arose out of such an upheaval. What immediately strikes you is the slenderness and elegance of the main staircase, and – in the reading room – the finesse with which the ferroconcrete beams are arranged and made to look like a wooden structure, with bevelled edges and cuts when they meet their supports.

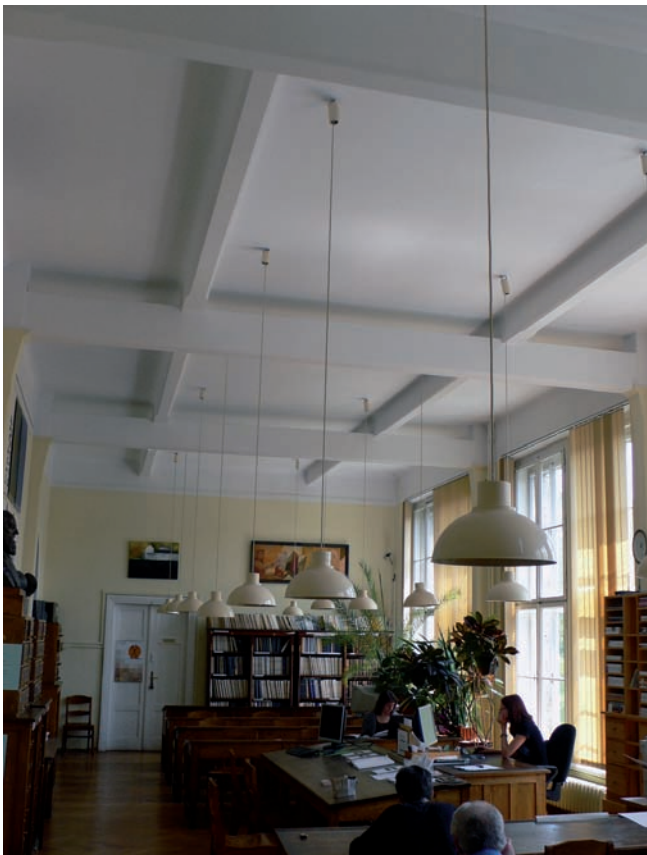
4. Kraków, Academy of Fine Arts Faculty of Industrial Design, reading room; floor structure as viewed from below: secondary beams resting on main beams which rest on posts adjacent to pillars between windows. Photo by W. Affelt

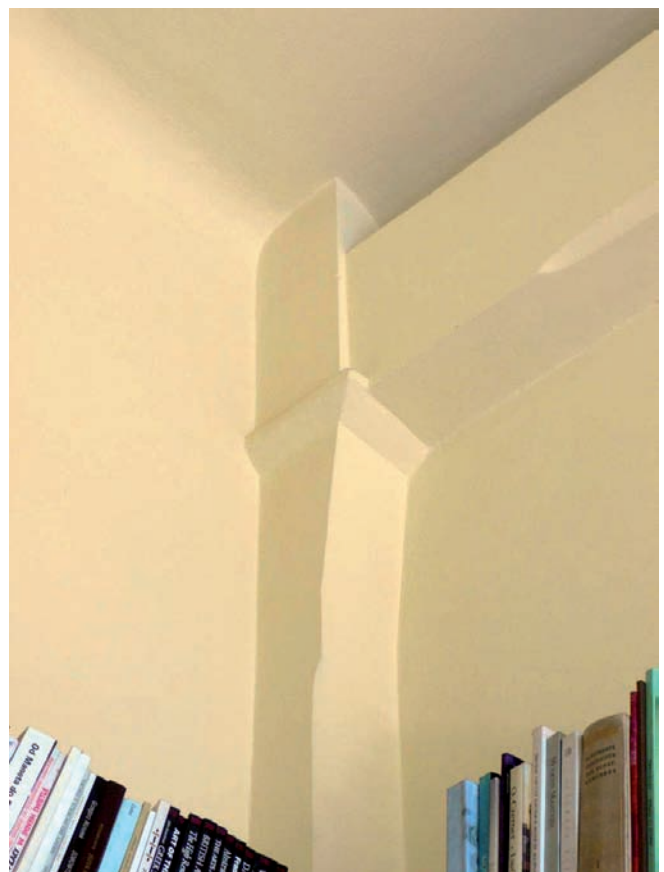
5. Kraków, Academy of Fine Arts Faculty of Industrial Design: room interior (possibly after alterations have been made), detail of the main beam support on a pillar; the shape of the edge of the ferroconcrete elements mimicking traditional carpentry woodwork is worth noting here. Photo by W. Affelt

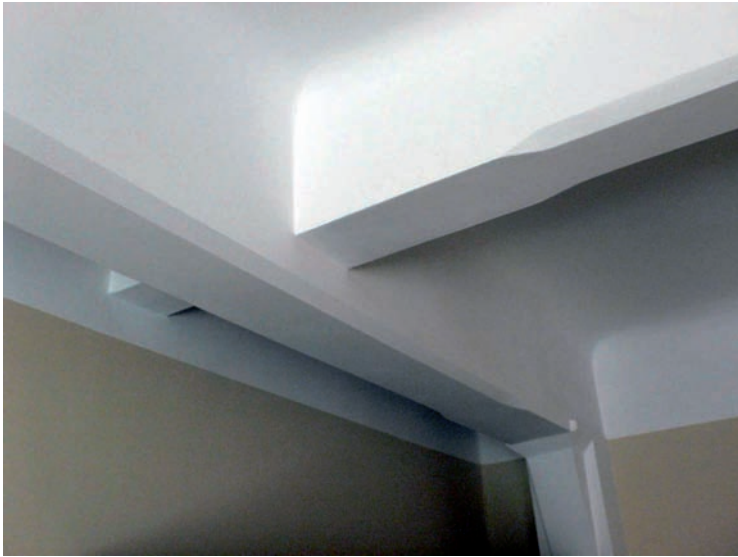
6. Kraków, Academy of Fine Arts Faculty of Industrial Design: detail of the massive ferroconcrete floor structure; what draws attention here is the shape of the edge of the ferroconcrete elements mimicking traditional carpentry woodwork. Photo by W. Affelt

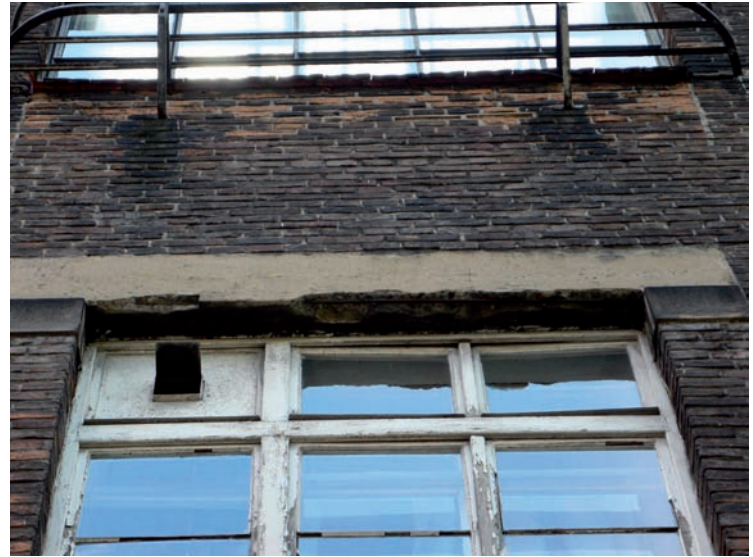
7. Kraków, Academy of Fine Arts Faculty of Industrial Design: rear elevation, detail of the reinforced concrete beam of a window lintel with a visible loss of the concrete covering of a rebar; this might be interpreted as a result of poor workmanship or corrosion caused by the lapse of a hundred years. Photo by W. Affelt (as of June 2009)
