## Interior Decor and Furnishings of Former Sanatorium in Trzebiechów by Henry van de Velde - Presentation of Research Results and Conservation Works in View to His Other Performances during the Weimar Period of His Work

Barbara Bielinis-Kopec

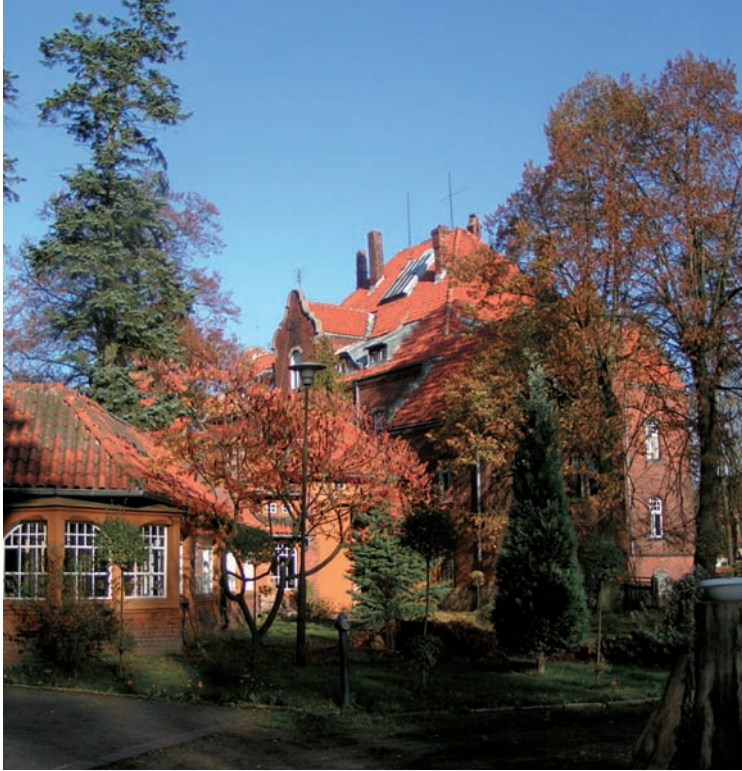
2. Doctor's House joined with sanatorium building by means of a catwalk at the ground level. Photo by B. Bielinis-Kopec

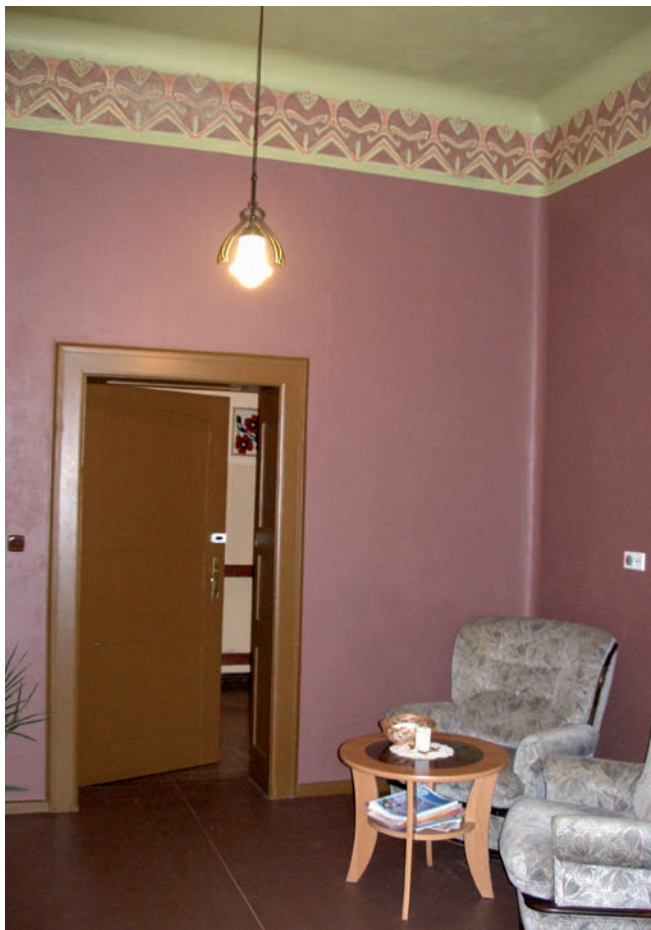
4. Former room for men after conservation and restoration works. Photo by B. Bielinis-Kopeć

A discovery in the gentlemen room was made that proves the author's change of decoration concept and indicates the personal participation of the artist - initially the frieze was about half the width and covered only the lower zone of the current ornament (in accordance with this concept the ceiling was to be painted reddish-orange), while after the change the frieze was widened to its present width and the ceiling was painted green.

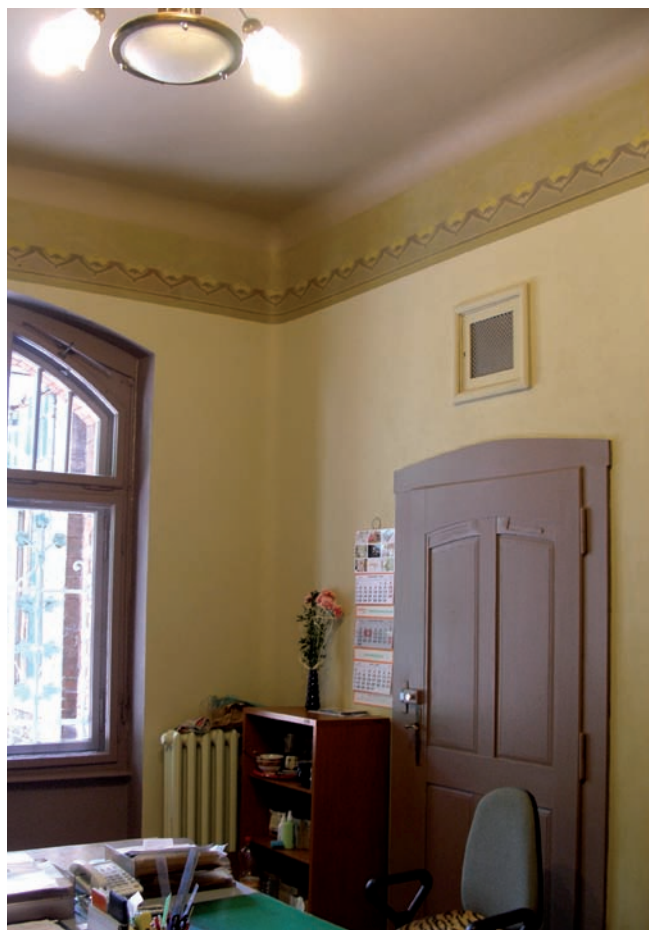
5. Former room for women after conservation and restoration works. Photo by B. Bielinis-Kopeć

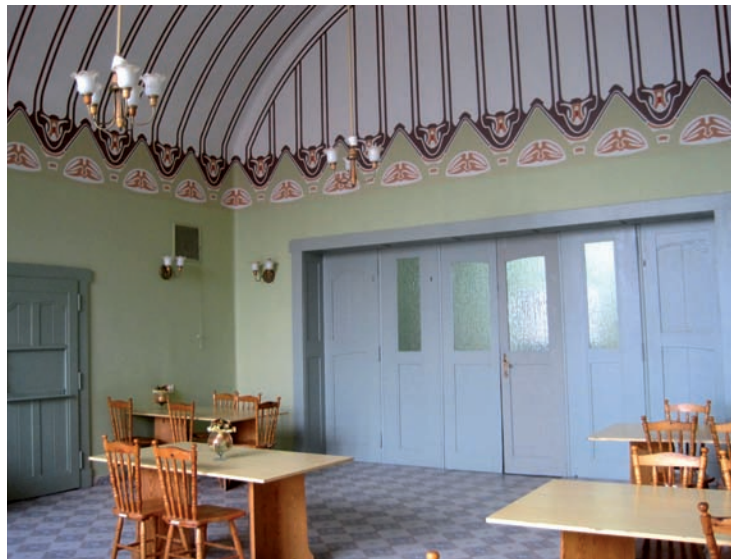
6. Dining room after restoration works. Photo by B. Bielinis-Kopec

In the same year conservation research and restoration works in the dining room were performed. It was found that the vault decoration known from iconographic evidence, was destroyed, so its reconstruction was resolved. Renovation works also included windows and doors to recreate its original light-grey colour.

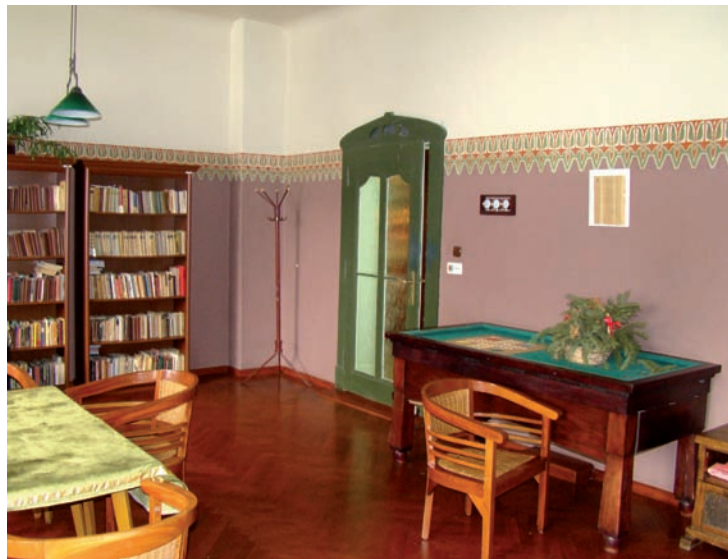
7. Former billiard room after conservation and restoration works. Photo by B. Bielinis-Kopec

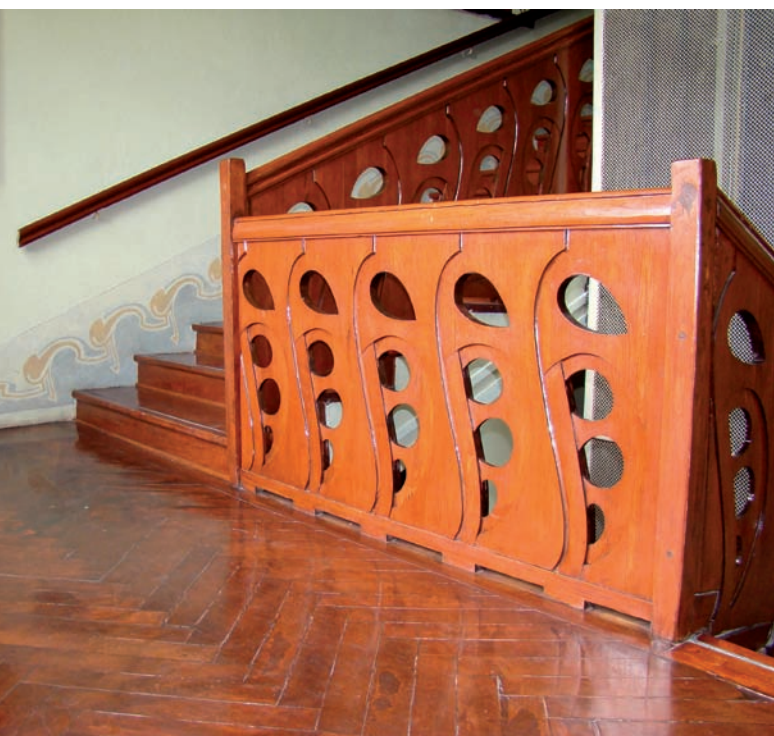
8. Balustrade of the main staircase in the sanatorium building. Photo by B. Bielinis-Kopec
