Exterior Plasterwork in Gdynia's Modernist Architecture and Its Preservation

Robert Hirsch

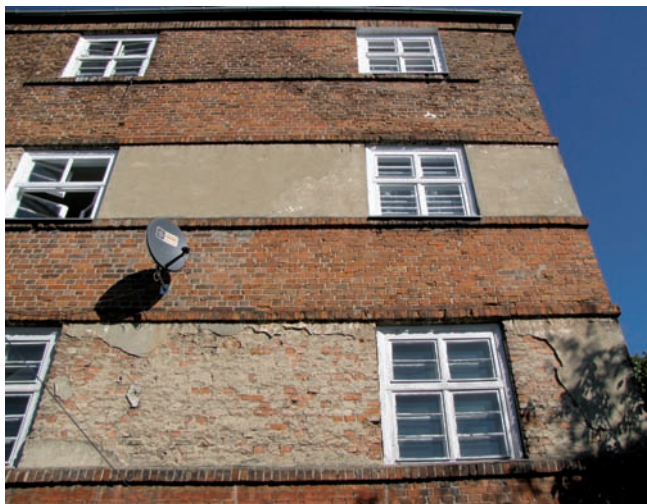
3. Detail of the 1928 Rice Mill building façade, where ordinary plaster finish was contrasted with face brick, status as at 2012

being contrasted with another material (Fig. 3). The façades' horizontally striped finish visually integrated the complex which included several rice-mill buildings of complimentary functions. The juxtaposition of smooth plaster with parts of the façade finished off with other materials will be used very frequently in modernist Gdynia architecture.

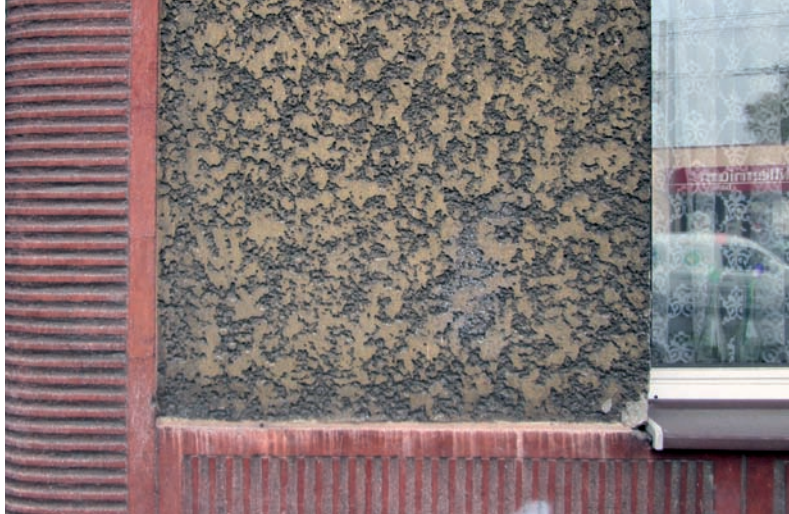
4. Rubbed Tyrolean render in yellow, in composition with red faux stonework render on a building façade at Chylońska 39, Gdynia

rubbed Tyrolean finish.¹⁹ Two different colours of the base coat and the textured finish coat could be used for an added decorative effect. This is how the smoothed-out surface was made to contrast with the concave parts. The passage of time additionally caused the concave porous parts of the finish to darken and provide a contrasting visual effect. Rubbed Tyrolean render has survived in Gdynia on many buildings, for example at Chylońska 39, where the surviving rubbed Tyrolean finish in yellow is contrasted with red faux stonework render (Fig. 4).

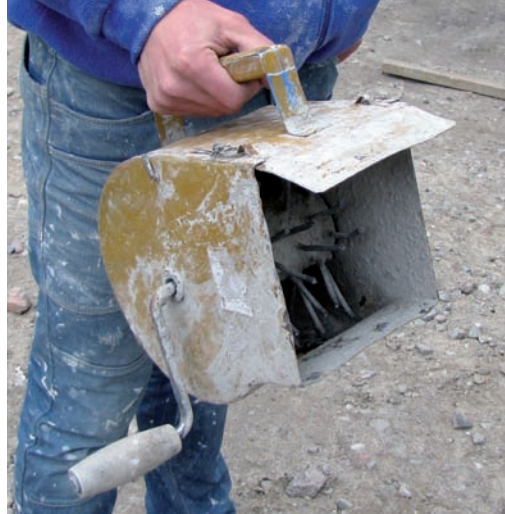
5. Tyrolean render applicator used to restore the façade in Gdynia

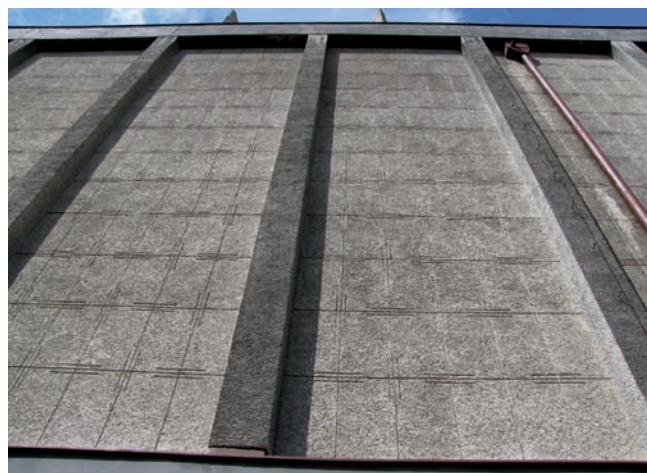
7. Scratch finish applied after World War II on the façade of the Most Sacred Heart of Jesus Catholic Church at Armii Krajowej St., Gdynia

on the building façade at Bema 5. Scratch render was very popular in Gdynia also after World War II. This type of finish was used, for example, on the façades of the Most Sacred Heart of Jesus Catholic Church at Armii Krajowej 46 (Fig. 7), as well as on pre-war buildings which were finished after the war, for example the townhouse at Świętojańska 55.

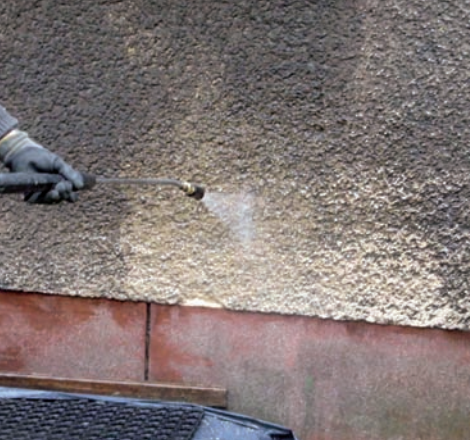
8. The original colour of the 1930s scratch render is revealed during a cleaning procedure (building at Bema 5, Gdynia, 2013)

In recent years, Gdynia's restoration projects have also come to include its historical scratch finishes, for example on townhouse façade at Bema 5. Completed in 2013, the work began with the plaster surface being cleaned by washing (Fig. 8). The project also included filling in the missing render fragments on this façade. After many tests and trials, the colours and type of aggregate were successfully chosen but it proved difficult to blend the filled-in surfaces with the original ones.

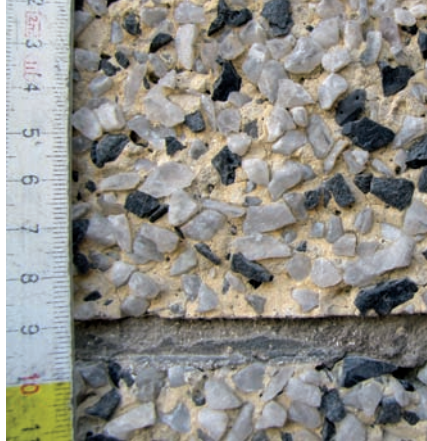
9. A view of the washed render texture on the façade of a townhouse at Świętojańska 47, Gdynia

Washed finish with white and black large-sized aggregate, but on a yellow binder, was applied on the frontal façade of the townhouse at Świętojańska 47 (Fig. 9). The yellow colour of the binder gives the façade a clearly yellowish appearance. In this case, the small rectangular fields of plaster were divided with narrow joints which had not been additionally highlighted. Washed finish was often combined with other façade materials and other types of render. In the Swedish Sailor House in Jana z Kolna 25, washed render was used as a visual element juxtaposed with red face brick surfaces. Washed finish, with white and black large-sized aggregate, was used in the entrance section. The rectangular fields of washed render were connected with narrow joints. The rectangular division of the washed render surface was determined by the technique used. The longer time required to complete this finish was reason enough to divide the façade into smaller fields, which could be completed at different times, while the joints helped achieve a uniform effect.

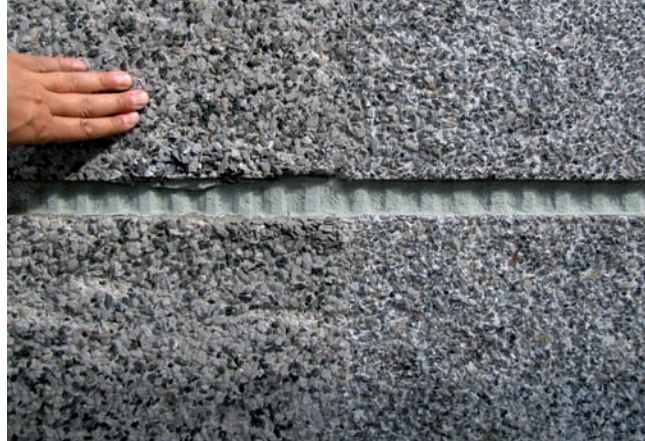
10. Washed render on the townhouse façade at Świętojańska 105, after restoration. Left - original finish, right - reconstructed finish.

Gdynia's experience with the restoration of washed render concerns several different façades. The largest scope of restoration work was performed in 2012 on a townhouse in Świętojańska 105. During the project, it was necessary to fill in the missing render over a significant surface. The biggest problem was not the rendering technique itself, which had been perfected after several tests. What proved difficult was to find the right aggregate, close to the original in both colour and size. After extended search, however, a good result and façade integrity were achieved. There is only a slight difference between the original and the filled-in fragments (Fig. 10).

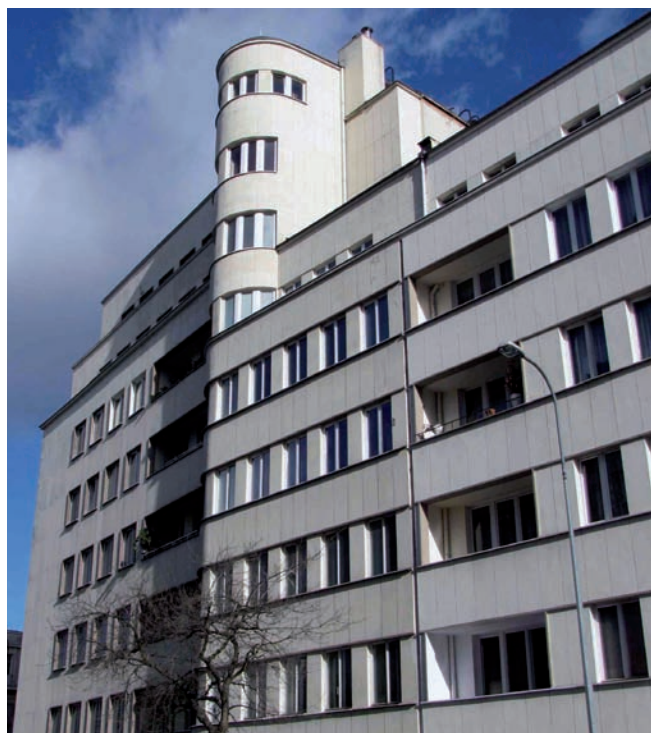
11. Building at 3 Maja 27-31; the façades are finished with natural stone (left-hand side up to the loggias) and imitation stone cladding render (right-hand side with the loggias)

The principle behind these types of finishes can be best observed on the exterior façades of the building at 3 Maja 27-31. This complex was built in three stages but the façades received great architectural integrity. The exterior façades of the first part built in 1935-36,²³ located at the intersection of 10 Lutego and 3 Maja streets, feature natural stone cladding. Meanwhile, the exterior façades from the two subsequent stages in 1937-39 were given a render which repeated the layout and sizes of the first part's stone cladding (Fig. 11). The façade's render finish superbly imitates stone slabs. These renders contained a lime binder with stone aggregate which was probably the ground stone from the building's first part.²⁴

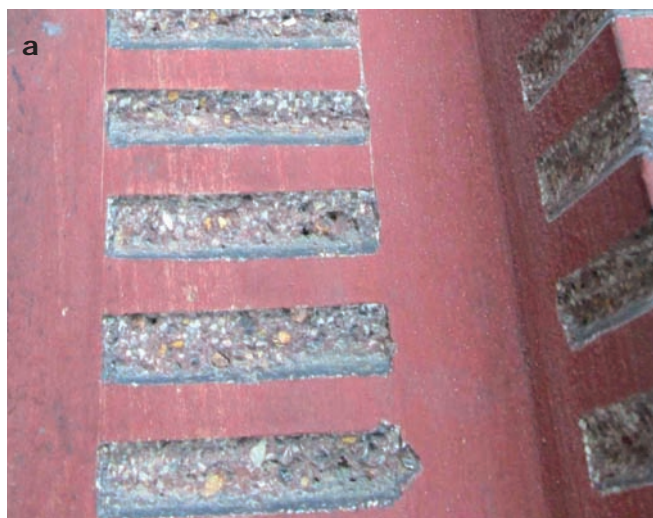
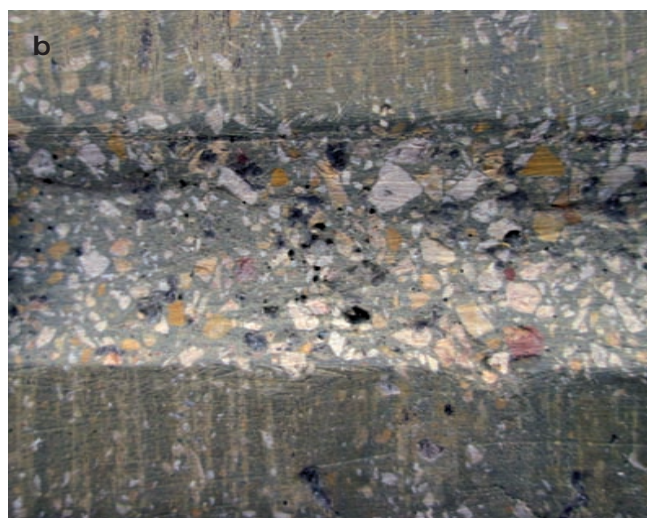
14 a, b. Faux stonework finish fragment with visible structure and workmanship detail

whole surface was tinted, usually in the colour of the binder, to obtain colour intensity. The next stage was to engrave a decorative pattern on the surface. This is proven by the traces of a burin visible in many places. Stencils could be used for complicated patterns to be engraved. Next, the background was chiselled out using stoneworking tools, for example a chisel, a bush hammer etc., while the decorative motif remained smooth and intensely coloured. The result was a flat, uniformly coloured surface and chiselled-out fragments which showed the structure of the material with the aggregate (Fig. 14 a, b).

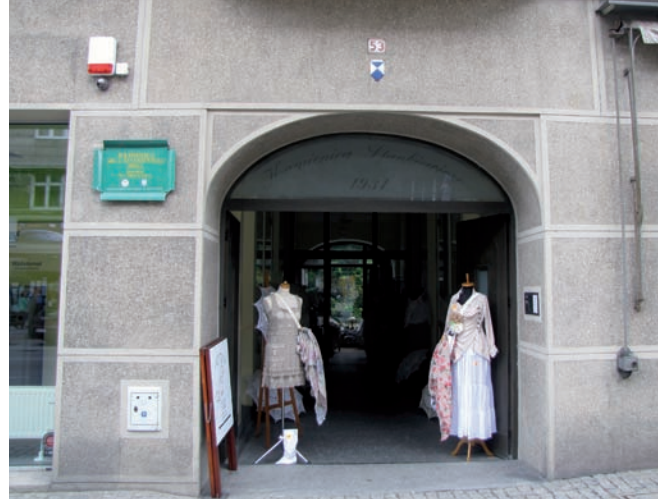
16. Faux stonework finish on the townhouse at Świętojańska 53, Gdynia, stylised to resemble stone cladding

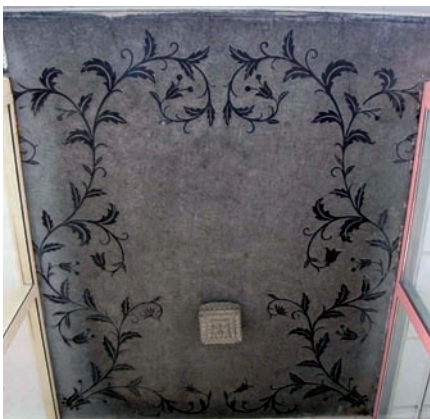
18. Detail of the townhouse ornamentation at Starowiejska 21, Gdynia, with a faux stonework finish folk motif

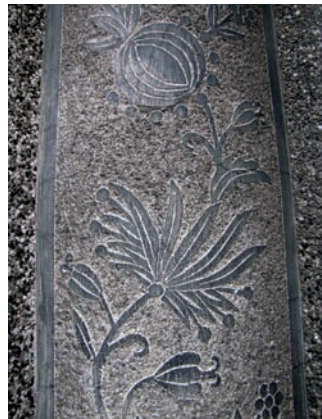
19. Detail of the townhouse portal ornamentation at Wolności 5, Gdynia, with a faux stonework finish folk motif

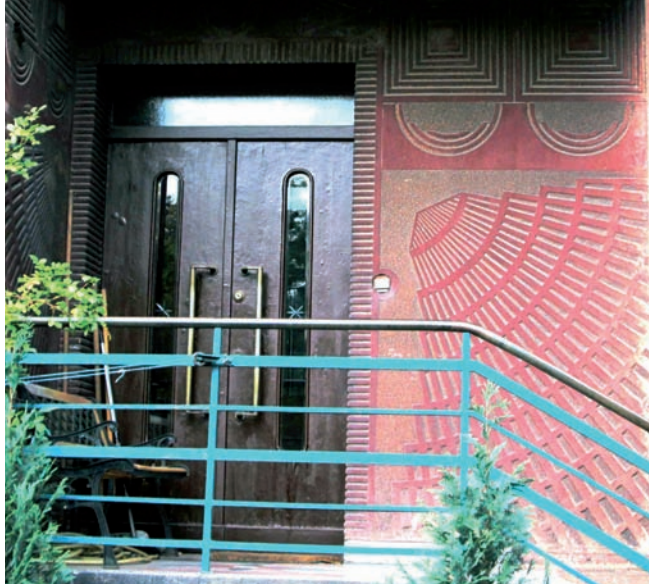
20. Faux stonework finish decoration at the building entrance, at Młyńska 23, Gdynia

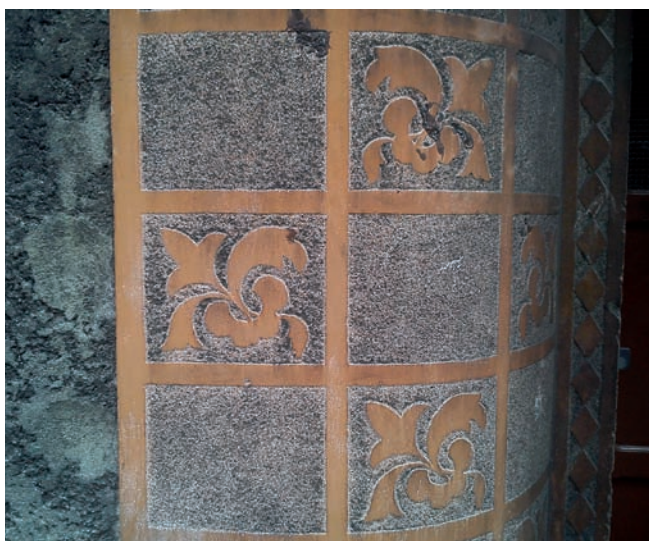
21. Detail of the townhouse façade at Mazowiecka 26a, Kraków, with faux stonework finish

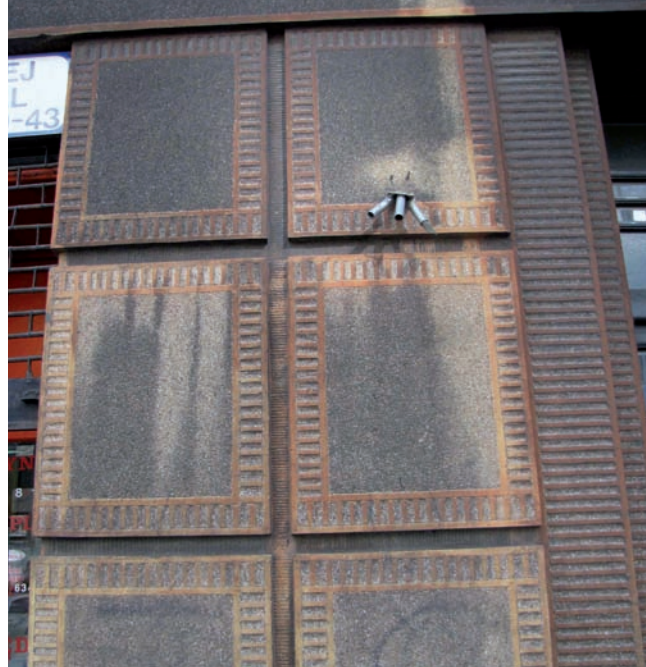
22. Detail of the townhouse portal decoration, Moniuszki 26, Toruń, with a repetitive decorative motif. Photo by Alina Limańska

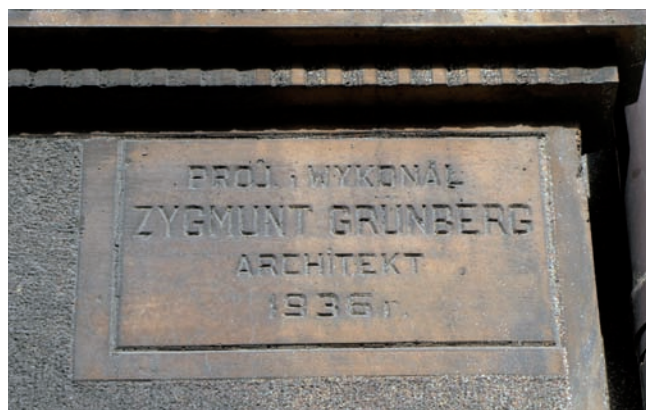
24. Fragment of a townhouse façade at Żuławskiego 8a, corner of Kolberga 17, Kraków, with faux stonework finish including the Litozyt logo

One of the best known producers of ready-to-use faux stonework dry mixes was the already mentioned Litozyt company of Krzeszowice. It manufactured Litozyt K, dedicated for faux stonework renders.³⁵ As touted by the producer, the mix was made exclusively from natural marble and, due to the "machine fabrication method", Litozyt was durable and defect-free. The company was probably also a contractor. The *Litozyt* company trademark - logo has survived on some 1930s façades in Kraków. This symbol can be seen on, for example, the townhouse at ul. Żuławskiego 8a, corner of Kolberga 17 (Fig. 24). Of course other producers also made faux stonework mixes, which allowed for a great diversity in façade solutions. The makers of render mixes distributed them all over Poland in the 1930s, which is why similar finish applications can be seen in many cities, albeit in various wall arrangements.

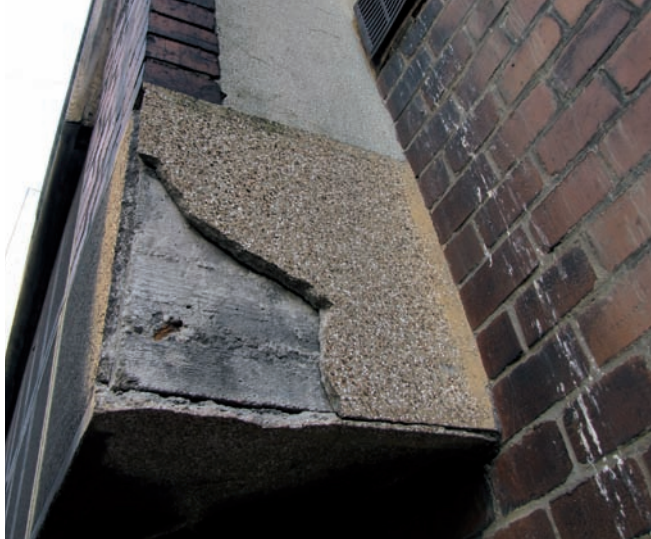
25. Faux stonework finish on a reinforced concrete bay window cantilever, townhouse in Katowice, *Stalmacha 23*

Faux stonework stucco offered many advantages which were utilised by modernist architecture. Because of its thin finishing coat, faux stonework render could be used on reinforced concrete structural elements, including cantilevers, thin pilasters and columns, to imitate stone slabs or blocks. Many such applications can be seen on buildings not just in Gdynia but also other cities (Fig. 25). The faux stonework rendering technique made it relatively easy to coat curved surfaces.

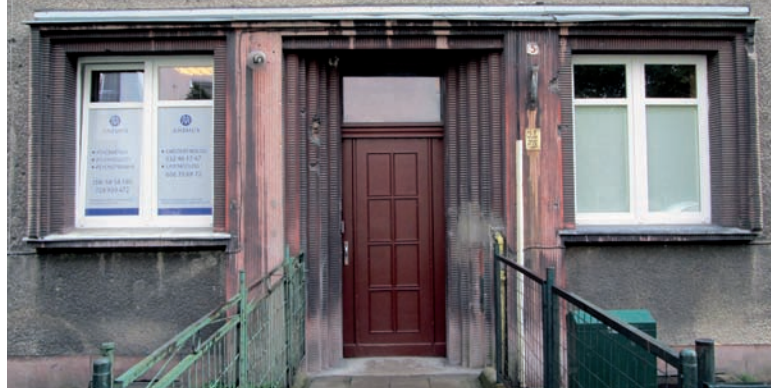
26. Portal at Bema 5; faux stonework finish before restoration

grooves as a decorative motif. The portal was preserved in a generally good condition but was damaged in many places, losing its visual appeal completely (Fig. 26-27a). The restoration brought it back close to its original condition. After the surface had been cleaned, all the major places of damage and cavities were repaired. The restoration was performed by a qualified heritage restorer, using methods close to the original technology. The cavities were filled in with coloured render with aggregate, to match the original. After sanding and tinting, decorative motifs were chiselled out. The final result is very close to the original (Fig. 27b-28).

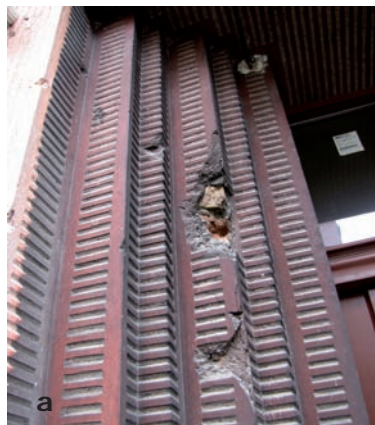
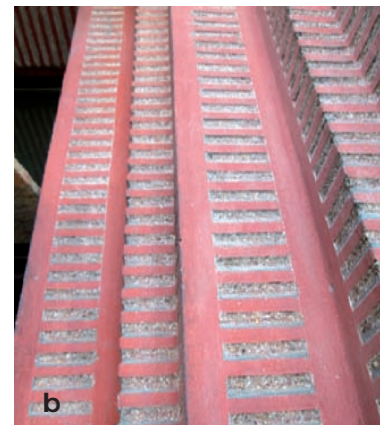
27 a, b. Detail of the portal at Bema 5, Gdynia, before and after restoration
