Latest Trends and Experience with Renovation of Modern Architecture Monuments in Slovakia

Veronika Kapišinská
Denis Haberland

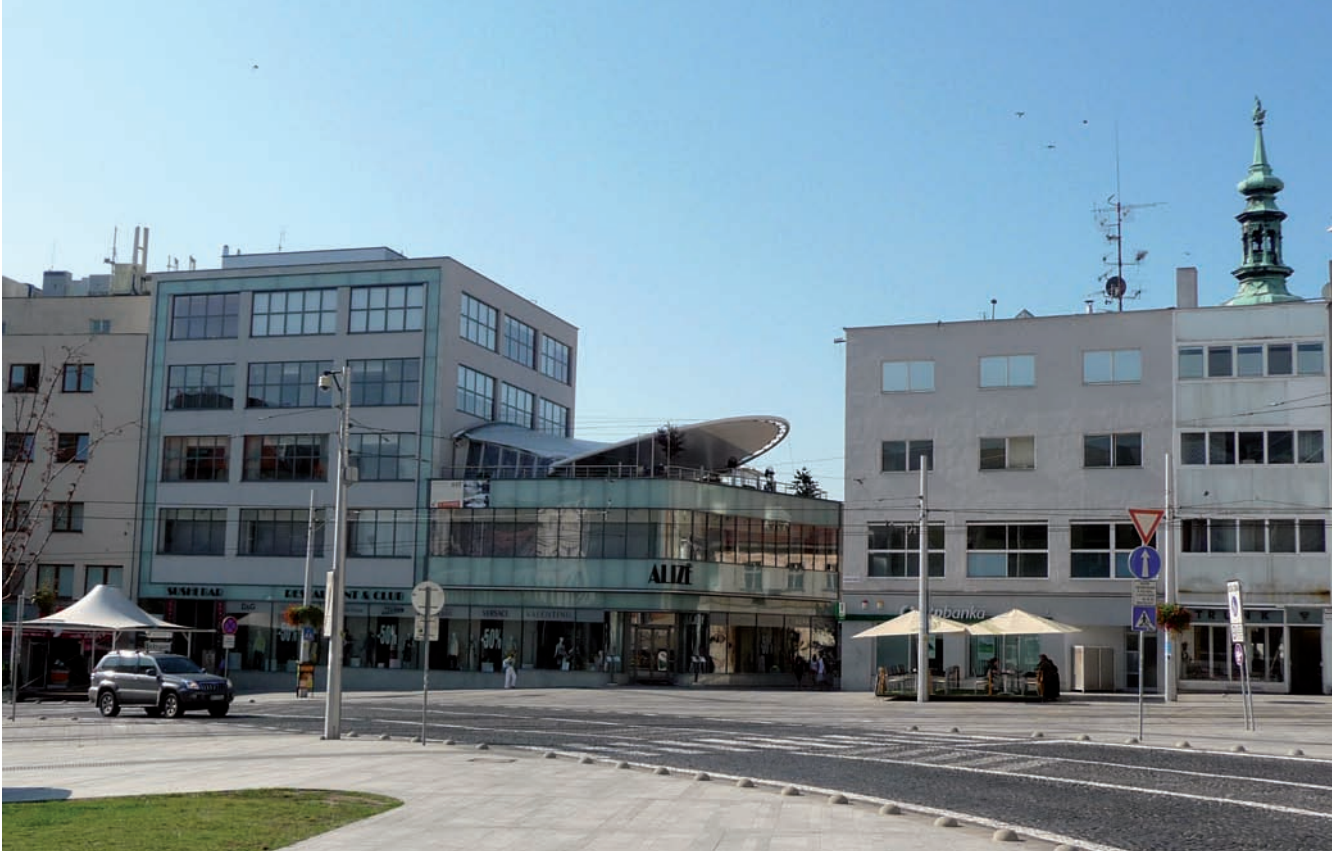
1. Present view of the Baťa Department Store, 1929-31 by Vladimír Karfík. Photo by V. Kapišinská, D. Haberland

The actual appearance of the building is a result of the last renovation realized in the years 2004-5. The group of architects confronted with the negative impacts of the previous architectural intervention had to face up a difficult problem, which was solved just partially by them. It was decided that all windows would be replaced (for the reason of insulating qualities enhancement) with replica windows, but their replacement posed several changes. It caused that window frames became more massive and lost their characteristic facing with the façade. But the atypical

external cladding was realized in the authentic articulation and colour design with recovering the surfaces of the specific Opaxit glass with applied neon lighting. In the interior the most invasive intervention was a new glass hydraulic lift pointlessly inserted into the centre of an open area, which caused the visual disturbance of that free-open space. At the same time post-additional and unused staircase tower remained stationary. Finally, the external view was disrupted by additional reversible terrace blind on the roof of the lower building part. On the other hand, the positive moment of this reconstruction was the restitution of the authentic entrance situated in the curved glass corner.

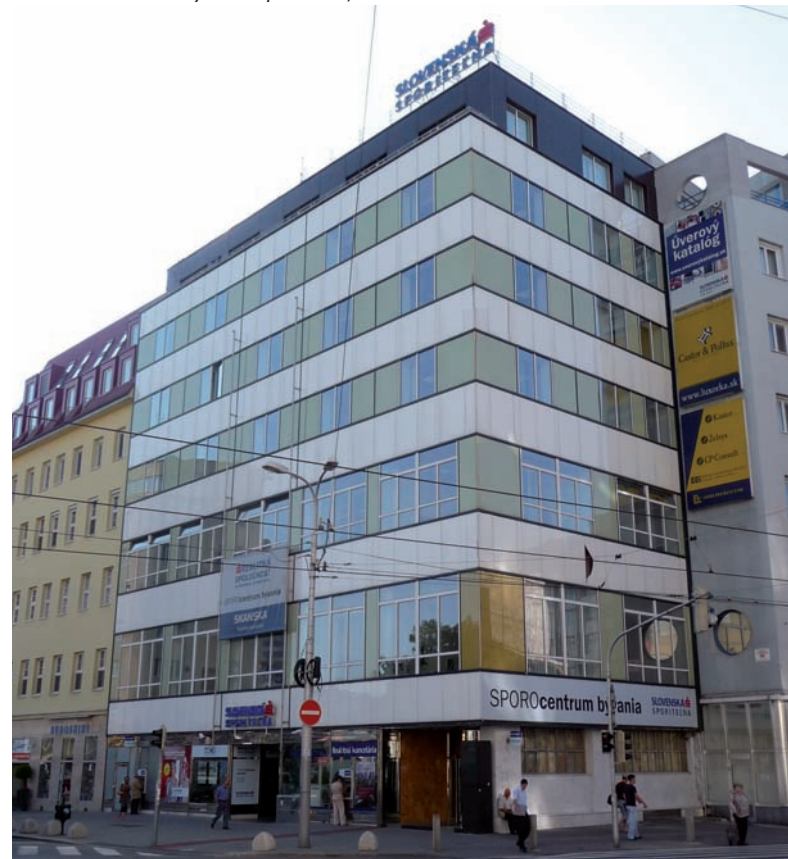
2. Cladding façade of the Slovak Savings Bank, 1929-32 by Juraj Tvarožek. Photo by V. Kapišinská, D. Haberland

The next example of an exceptional work of its time is the building of Slovak Savings Bank, originally designed by Juraj Tvarožek in 1929-32. It was a revolutionary creation thanks to a hanging coloured glass façade (Fig. 2). Hanged up to the concrete-steel structure this façade represented the technical innovation not only in the surrounding of Bratislava but also abroad of Slovakia. Behind an innovative façade there was hidden a more serious classical interior with high culture of architectural details. Over the years building survived the number of partial repairs. The insensitive renovation realized in 1973-75 was the cause of the parterre organisation changes and substitution of a lot of authentic details by unvalued replicas. After all of this the complete reconstruction took place in 1998.

The renovation of façade was, of course, the most observed one, because it should have helped to reconstitute the authentic vision and horizontal character of the exterior. Even though the original windows were substituted by plastic

replicas, the optical appearance of their earlier thin profiles was simulated by at least partial covering of their frames and by its two-coloured design. Also the Opaxit parapets were strictly reconstructed. In the spaces between windows the Opaxit material was replaced by an enamelled glass, which allowed using of large solid sheets. Finally, the described reconstruction can be assessed as a relatively successfully managed one showing respect to the original work of functionalist architecture.

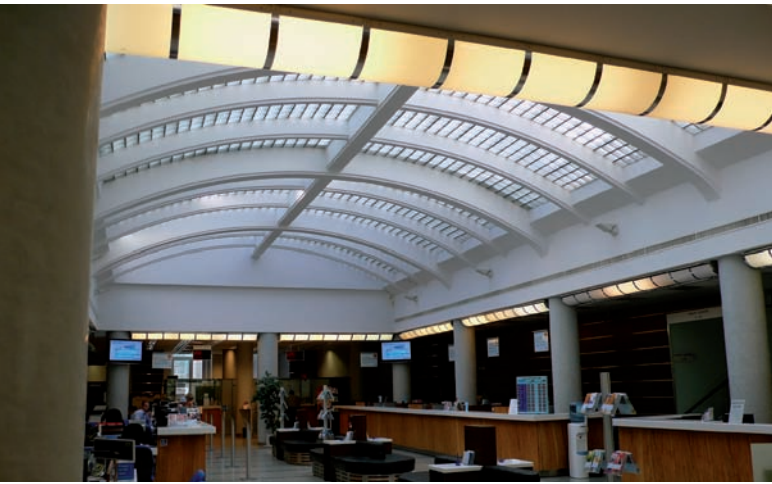
3. Teller hall in Slovak Savings Bank vaulted by glass-concrete arc. Photo by V. Kapišinská, D. Haberland

Until this day the dominative space of the object is a teller hall vaulted by an impressive glass-concrete arc (Fig. 3). The original glass-concrete bricks had to be substituted during the renovation, but the composition and mild profiles of the edges of the load-bearing elements remained the same. The careful methods have been chosen also in the case of the authentic interior parts, which were precisely renovated. By the restoration process the staircase entrance facing of onyx and semi-cylindrical linear lamp were renewed (Fig. 4). The reconstruction of unpreserved architectural parts was completed according to the historical documents and photos.

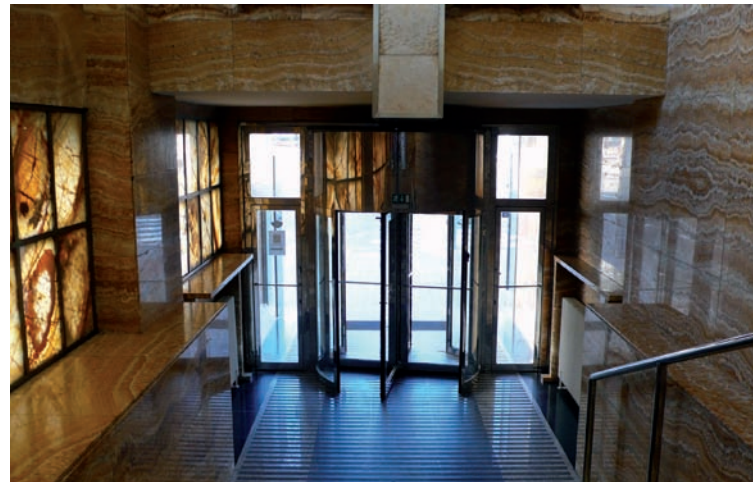
4. View of the staircase entrance facing of onyx of the Slovak Savings Bank. Photo by V. Kapišinská, D. Haberland

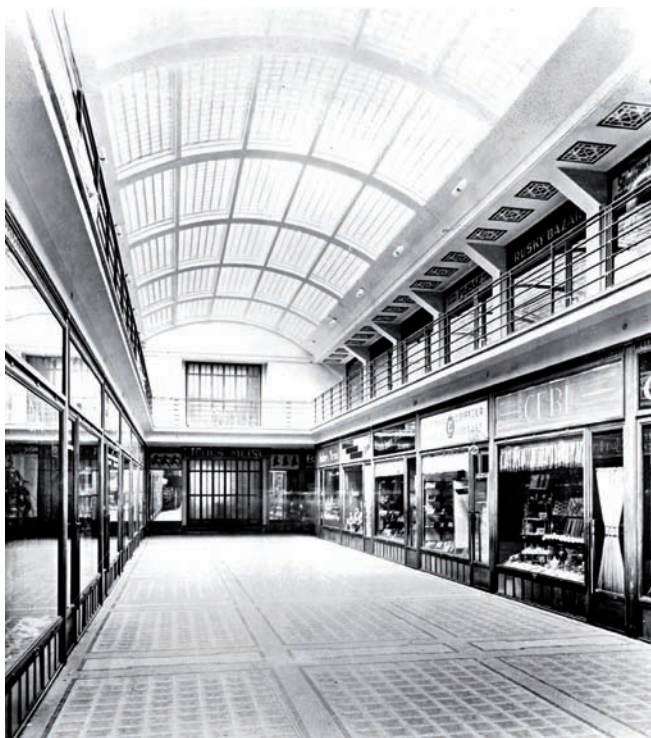
5. Historical photo of the original appearance of the Central Passage, 1928-29 by Andrej Szönyi and František Wimmer. Archive photo

Very interesting is also the story of reconstruction of the Central Passage, which was the first modern department passage of its times created in the first modern department store in Bratislava. It was erected in 1928-9 according to the projects of Andrej Szönyi and František Wimmer influenced by the Wagner school and the progressive movement of Functionalism (Fig. 5). Contrary to the aforementioned example of the Slovak Savings Bank, in this case the classical external cladding of the building sheltered a modern experimental interior. The long two-storied shopping gallery was roofed by concrete-steel vaulting with glass-concrete filling. The glass-concrete was applied also into the floor, which provided a natural light into the stores in the basement.

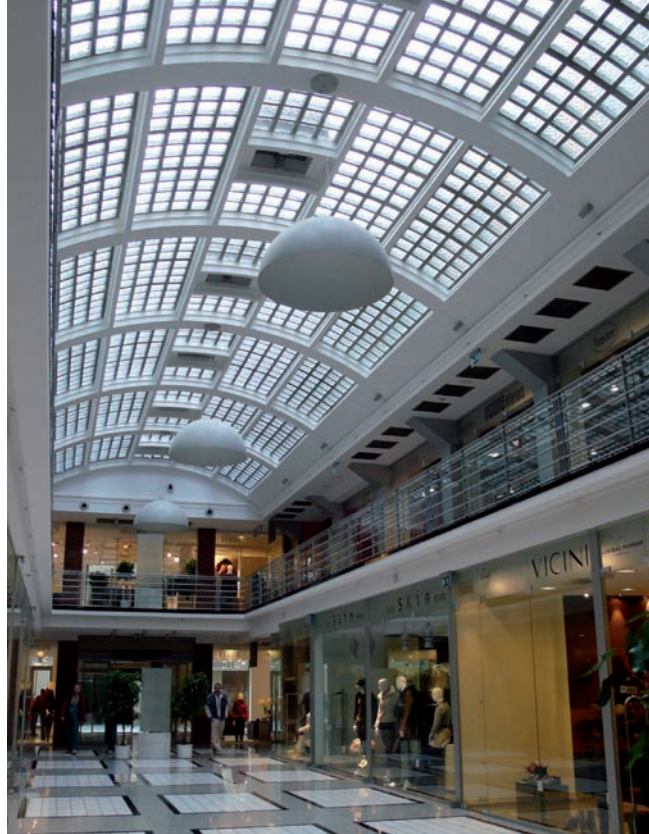
6. View of the Central Passage after restoration in 2005-06. Photo by V. Kapišinská, D. Haberland

In comparison with other described objects, secondary alternations to the Central Passage were minor and it has remained basically unaltered,⁴ almost in the authentic appearance with well preserved original details. But it was out of use and abandoned for a long time and this fact reflected in its bad condition. Its final complex renovation from the years of 2005-6 meant its immediate retrieval, but on the other hand it was accompanied with the same compromise solutions (Fig. 6). The authentic patent "Kraus windows" were replaced because of their material devastation. Unfortunately, in spite of the primary intentions of the reconstruction's authors, the illumination of the basement by the glass-concrete floor was finally not realised (it is just marked in the floor paving). The reconstruction of the authentic details involved in particular the reparation of the original steel railings of gallery. Thanks to the professional reparation they have remained, but they were additionally completed by controversial glass

sheets, which make a fiction of higher quality of the applied material. Unfortunately, the similar authentic steel railings of staircases were substituted by their expensive imitation with glossy surface, for the purpose of corresponding with the new luxurious concept of a hotel building.

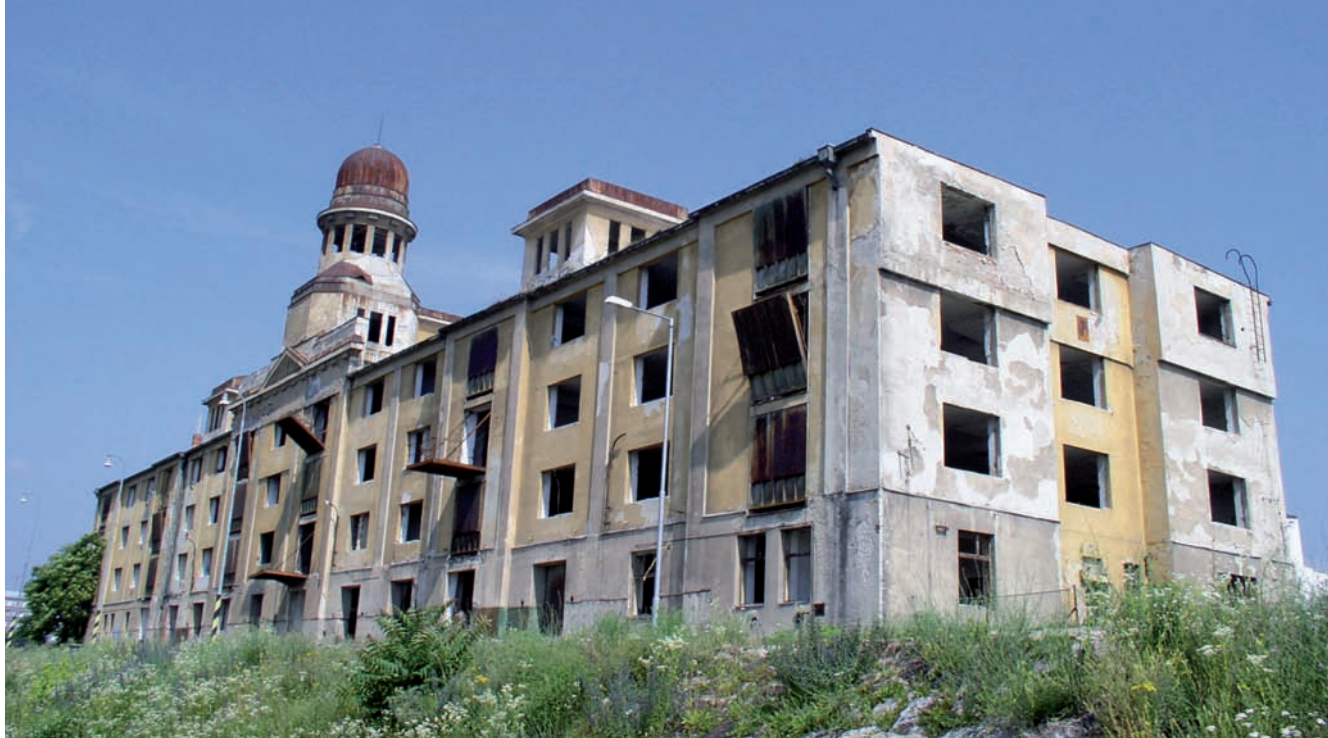
7. View of the abandoned Storage House No. 7 before restoration, 1921-22 by Karol Skorkovský

One of the few remaining industrial buildings in Bratislava, which were almost completely destroyed in the last years of the city development, is the object of the Danubian Winter Docks – Storage House No. 7. It was designed and also built by Karol Skorkovský in the years of 1921-22 (Fig. 7). The huge building situated in the exposed part of the left bank of the river was constructed as a five-storied concrete-steel framed structure (as one of the first in Slovakia)⁵ in the symmetrical composition with a terraced roof and three towers in the classical design. The authentic plain rendered façades were articulated by four rows of windows and loading openings with tailgates and line of leading ramp. After long years of its existence without using and its gradual degradation, the Storage House No. 7 was partially renovated in 2006-07 within the new city district development (Fig. 8). The reconstruction was aimed especially on the façades, the roof and towers, as well as the interior of the second floor, which was adapted for a promotion office where the models of offices and flats of a newly-developing residence city section are situated. The metal windows were replaced by duplicates consisting of a thin aluminium frame and heat-absorbing glass. The tailgates were removed and substituted by metal grate balconies with glass railings in the same dimension as the tailgates were. But in the interior the tailgates opening mechanism was preserved as a reminder of their original function. There was put the contact façade thermal insulation on the basis of rockwool without breaking building tectonics.

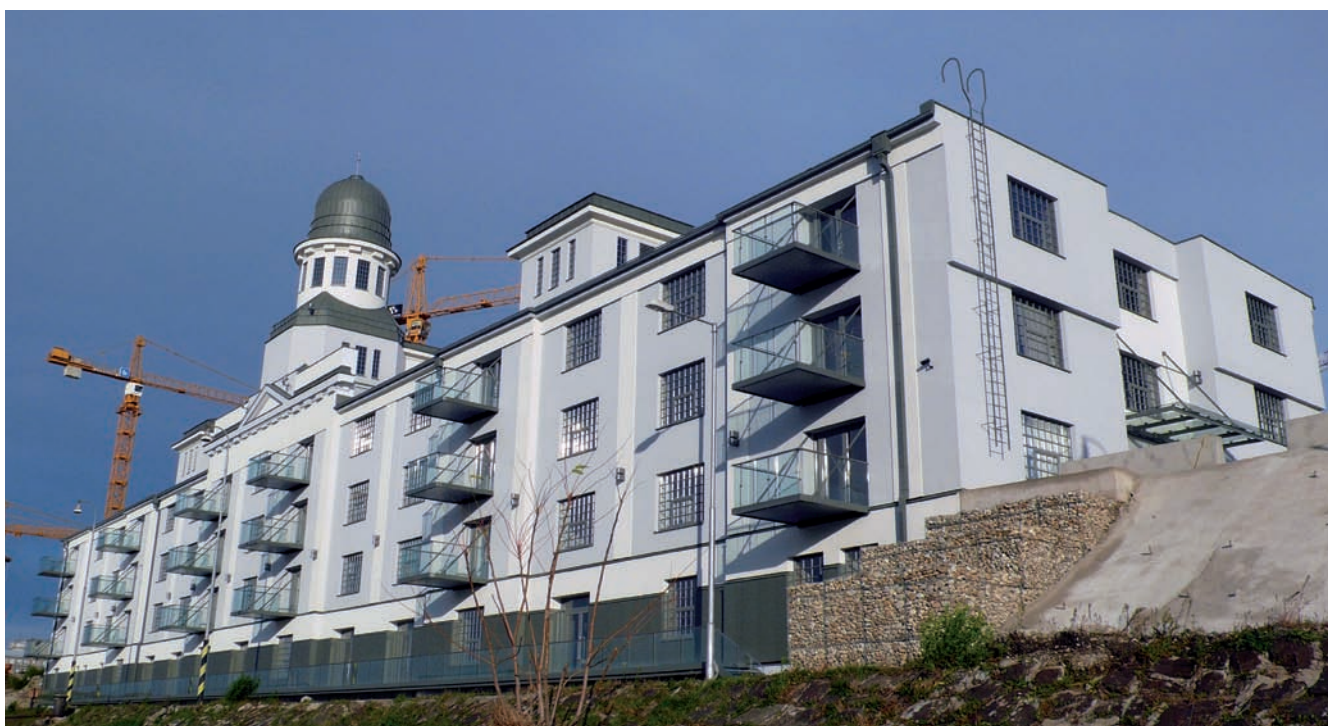
8. Present view of the Storage House No. 7 after restoration in 2006-07. Photo by V. Kapišinská, D. Haberland

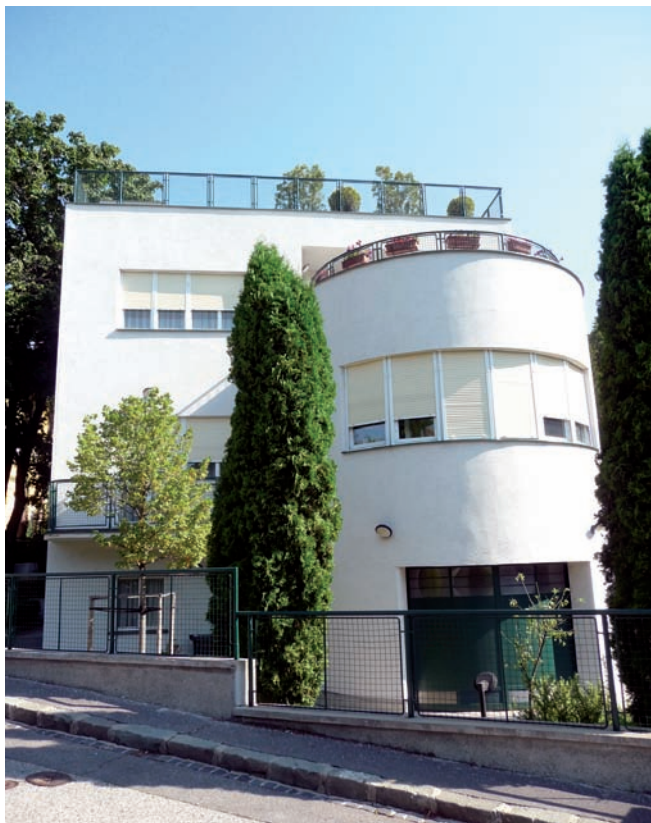
9. Present view of the Villa on Porubského Street 1, 1936-37 by Ernst Spitzer. Photo by V. Kapišinská, D. Haberland

In conclusion, to complete the wide range of functionalist buildings in Bratislava we will mention the example of reconstruction of the "Villa on Porubského Street 1" (Fig. 9). It was built near the centre of the city according to the project of Ernst Spitzer in 1936-37. The architect used the roof terrace and applied details inspired by typical steamer-like aesthetics such as the captain's bridge or steel railings with netting.

of accommodation comfort.⁶ Aside of these complicating starting-points the example of Villa on Porubského Street is an exemplary demonstration of the precise reconstruction of a functionalist object. The successful renovation realized in 2001-02 came up to expectations directed to the maximal preservation of its authenticity. The metal and stone elements were rehabilitated exclusively by the method of conservation, as well as the high quality interior details made up of classical materials such as yellow copper, glazed stone or wood. That is why the wooden sliding wall and stone cladding of the walls in living room and vestibule are still the component parts of the villa's original furnishing.

A specific problem was the renovation of the façade surfaces. On the basis of a sounder research the authentic plaster layers and details of façades were verified. The investigation also included the metal elements such as

railings, ladders or plumber details. According to the verified original plaster, which was partially reconstructed, a typical lime cement plaster was applied, containing fine-grained fraction of gravel and with smoothed surfacing with white coat of paint. The green paint of metal elements was renewed by the method of conservation too. The same attention was paid to the authentic fencing.

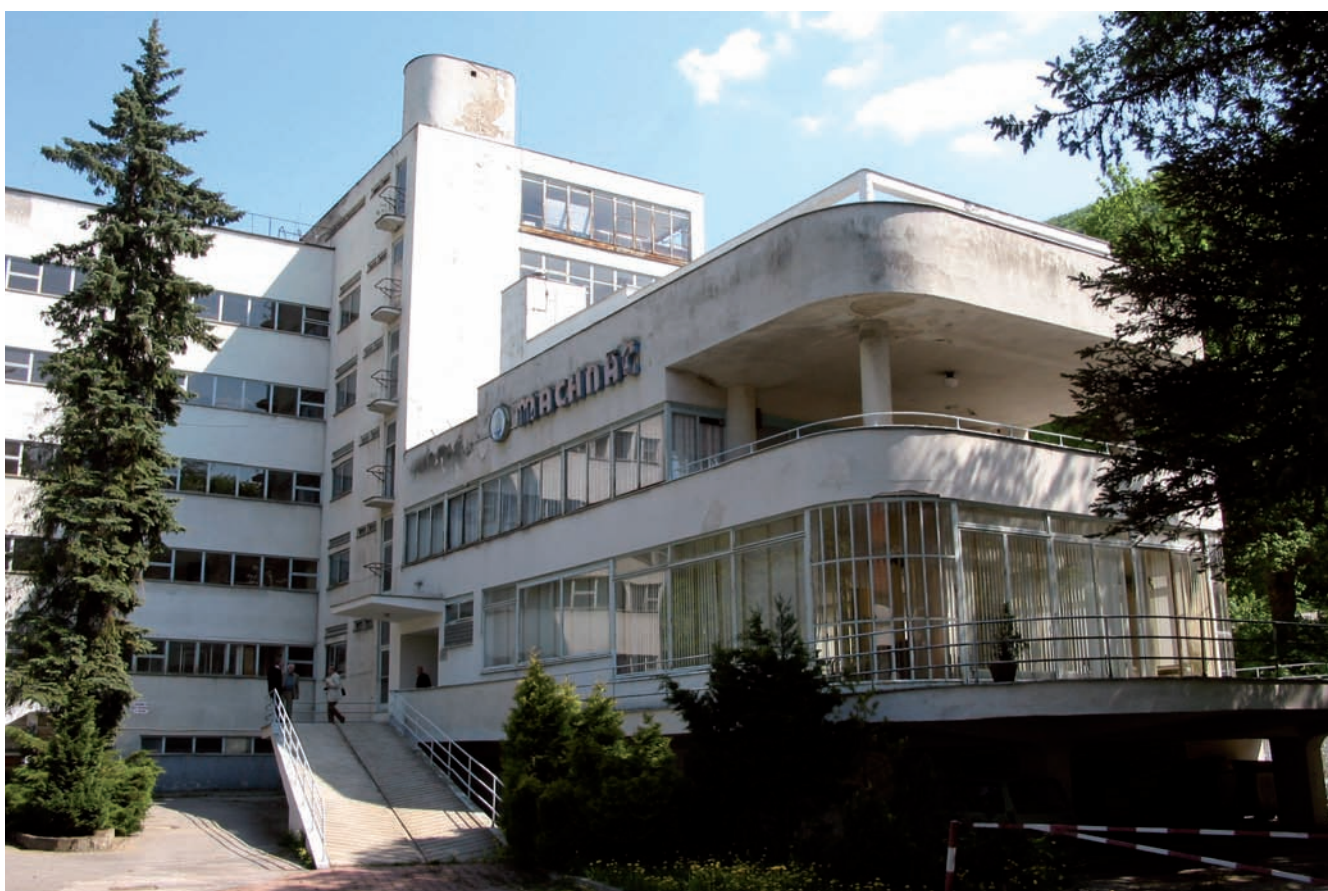
10. Sanatorium Machnáč in Trenčianske Teplice, 1930-32 by Jaromír Krejcar, waiting for reconstruction. Photo by V. Kapišinská, D. Haberland

But the question of principal attitude towards the renewal of modern architecture is still open and it appears as the most discussed problem. The subject to discuss is also the degree and limits of its protection. The examples of precise reconstructions are rare. The methods of modernisation or adaptation with more radically material substitutions following contemporary standards are more frequently used. We still feel as a great challenge also the need to affect public opinion in the direction of the necessity of modern architecture preservation, as well as to raise awareness of its historical and cultural importance, which is often minimized. It is especially this architecture that is often in direct danger, arising from the increasing building activity. In this aspect it will be very interesting to see how the investor, planners and the Monuments Board in cooperation will face up the expected renewal of an emblematic monument – The Sanatorium Machnáč in Trenčianske Teplice included in the DOCOMOMO register. The number of technical issues have to be resolved there. The result can be a regress or an exemplary model for reconstruction of the other architectures of the interwar but also the post-war period, which are waiting for it (Fig. 10).
