Conservation of Modernist Architecture in Poland. Practice in Recent Years

Jakub Lewicki

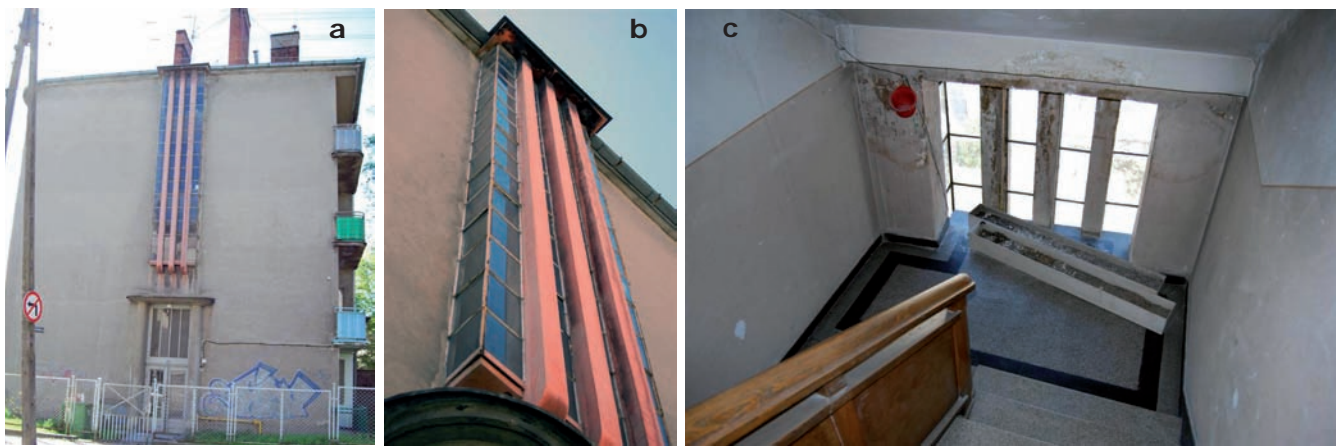
1. One of the most vital conservation problems connected with elevation conservation – meeting present-day standards of thermal protection by single-layer glass screens. Typical lighting of the stairwell by means of single-layer openings glazed with steel-framed panes. Visible leaks round the opening, frost and damp patches on the wall. Toruń, on the corner of Moniuszki and 17 Krasieńskiego street, the 1930s. 1a. General view; 1b. Central fragment of elevation with window; 1c. View from the inside. Photo by J. Lewicki, 2008

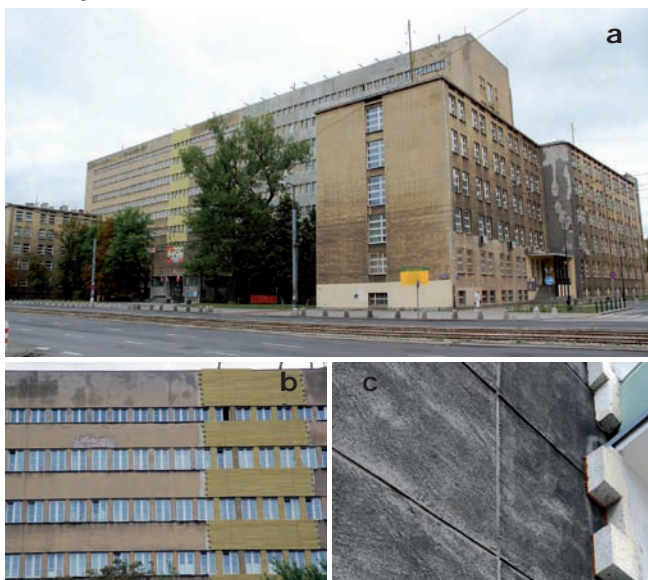
2. Typical process of insulating the elevation using the dry method. Building was originally covered with coarse double-layer plaster with regular geometric divisions made in the top layer - Warsaw, 218 Al. Niepodległości, completed in 1939. 2a. General view of the building; 2b. Fragment of the insulated elevation; 2c. Fragment of the insulation course; visible considerable thickness of the insulating layer and blurring of the wall texture. Photo by J. Lewicki, 2008

as their application is connected with changing the plaster coating. It poses yet another threat, as long as the plaster finish has a characteristic texture and colour scheme, or clearly visible admixtures – such as e.g. dark aggregate added to mass, mica elements giving the plaster finish a characteristic shine. Original plaster coating, besides external decorative elements such as ceramic and stone facing, woodwork and ornamental details, decide about the preserved authenticity of the interior décor in a modernist building. Varieties of colourful terrazzo, difficult to recreate because of the colour and texture differences of new fill-ins, are a serious problem. It also refers to original materials used for interior decoration: marble and ceramic facing with specially selected matching patterns, colours and texture. The final element are damaged fragments of original door and window frames with original glazing, and specialist fragments of interior furnishings: wooden fitted cupboards, partitions, linoleum used as interior floor lining or specialist historic medical or signalling installations, impossible to recreate in modern conditions. Some of those details are no longer used like, for example, wooden cupboards usually fitted below the window sill, which served as fridges or cold stores in kitchens adjoining living rooms. The impossibility to use some old fragments of interior decoration is a basic problem in preserving the original décor and function of functionalist interiors.

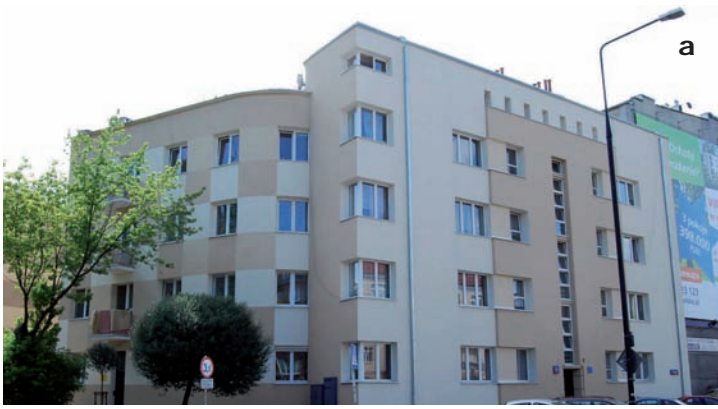
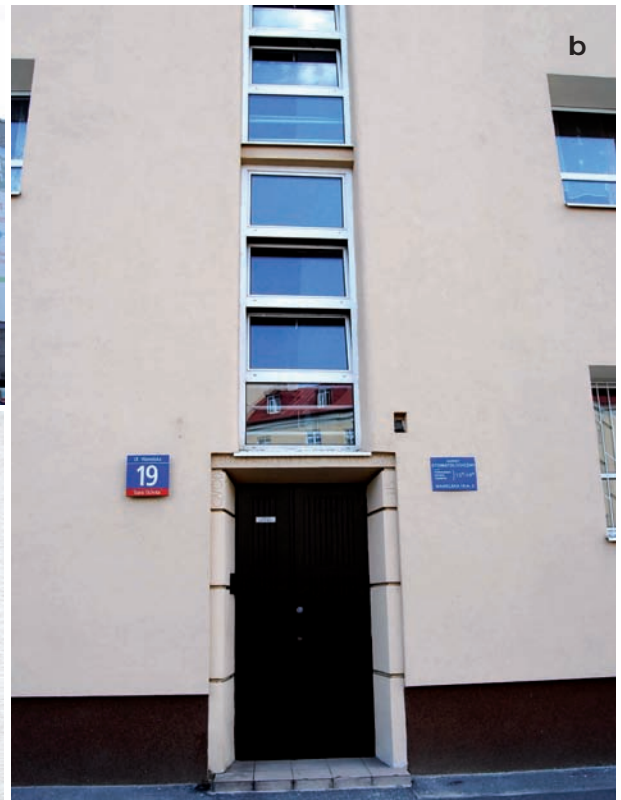
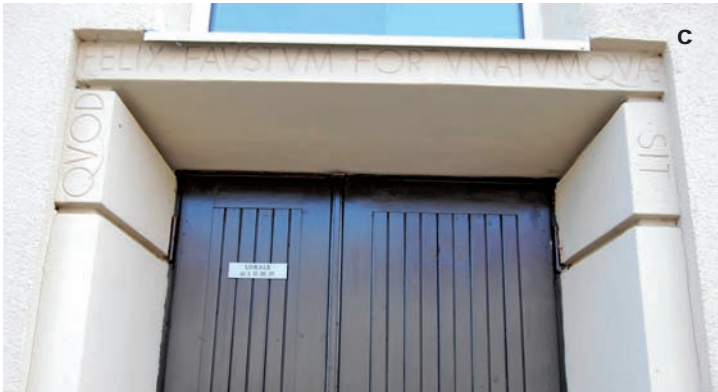
3. Typical elevation of a residential building after insulating it using the dry method. Visible change in the texture, colouring and finishing of the façade. **3a.** General view of the building; **3b.** Central fragment of the insulated elevation; **3c.** Fragment of the entrance – visible “disappearance” of once protruding architectonic frame of the entrance and deformation of the sentence around the entrance. Warsaw, 19 Wawelska St., designed at the beginning of the 1930s. Photo by J. Lewicki, 2010

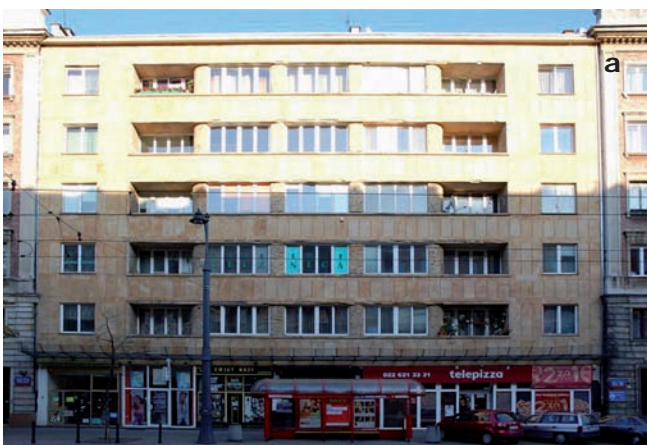
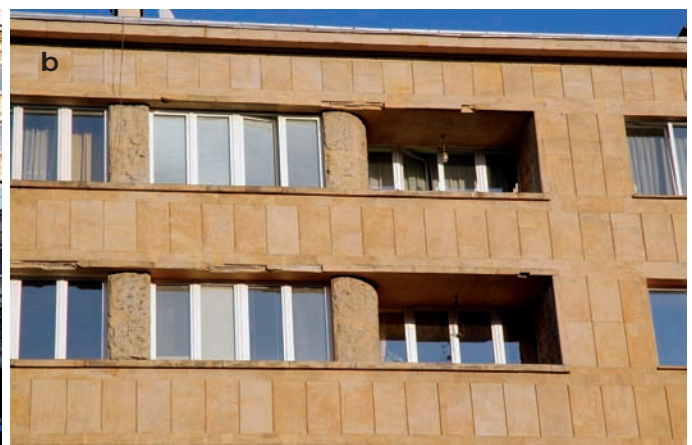
4. Elevation lined with sandstone. Visible discolouration of stone resulting from improper cleaning of the elevation. Warsaw, Oskar Robinson’s tenement house, then of the Związek Emerytów BGK, 18 Marszałkowska St., designed by Lucjan Korngold 1935-36. **4a.** General view; **4b.** Fragment of elevation. Photo by J. Lewicki, 2009

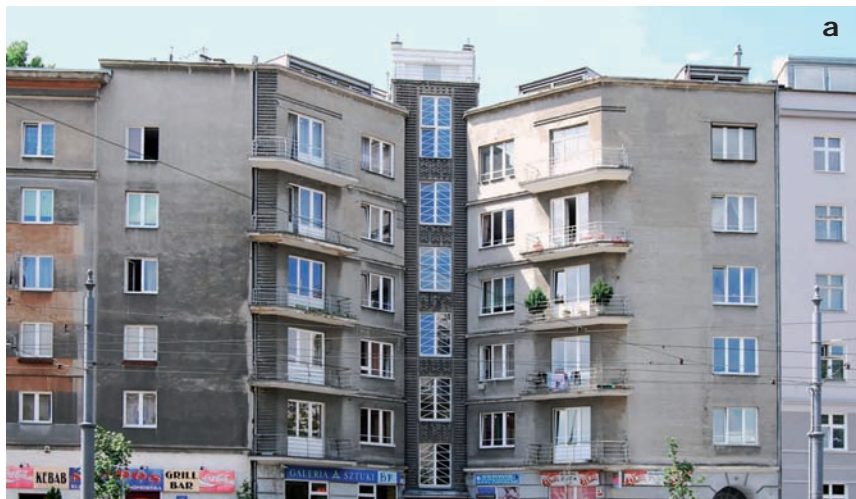
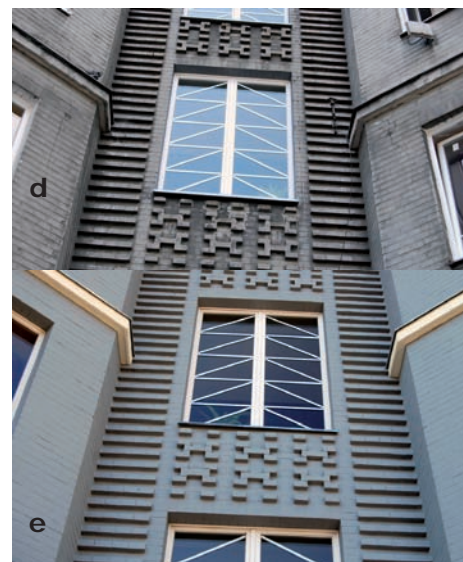
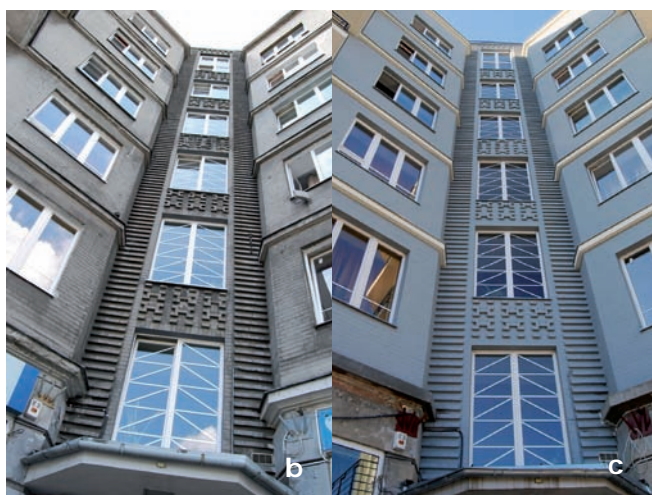
5. Elevation from grey cement brick laid in patterns. State before and after conservation renovation - Warsaw, tenement house belonging to the Spółdzielnia Budowlano-Mieszkaniowa "Grójecka 40A", 40a Grójecka St., designed by Władysław Nałęcz Raczzyński, 1930-31. Visible deformations in texture and colouring resulting from preserving secondary accumulations on the bricks during conservation work, and leaving them as chronologically valuable layers. 5a. General view; 5b-5c. Central fragment of the elevation. State before and after the work; 5d-5e. Detail, view. State before and after the work. Photo by J. Lewicki, 2010

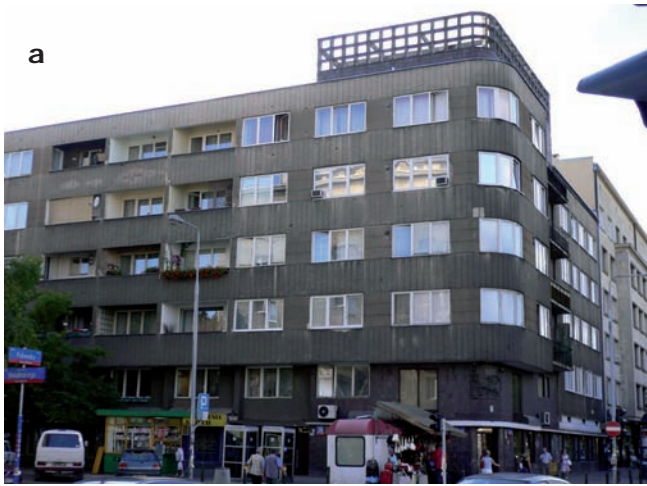
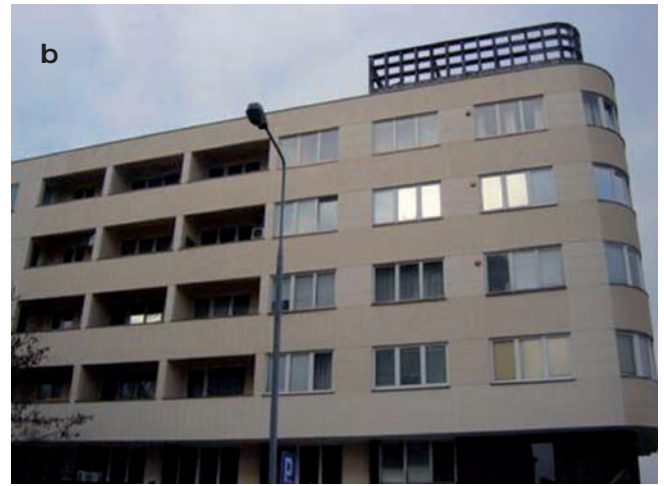
6. Warsaw, Wedel House, 28 Puławska St., designed by Juliusz Żórawski, 1935-38. A model building from the current of luxurious functionalism. Example of elevation destruction as a result of not recognising its high architectonic value. **6a.** Façade before the plaster replacement; **6b.** View after the plaster replacement. Photo: J. Lewicki 2008-2010. Visible differences in colouring and texture of the new finish. Architect J. Żórawski believed the plaster finish with a uniform finishing coat and variety of colour to be the most important element of the façade finish, which is confirmed by his recorded comments and accounts of workers erecting the building. The ideal finishing coat of the newly applied plaster was controlled by Żurawski at night by means of special lanterns illuminating it from the bottom upwards, which revealed all the irregularities and colour differences

under conservator's supervision or with conservator's subsidising. The best known realisation was the conservation of the elevation in the Wedel House in Puławska Street (Wedel House, 28 Puławska St., designed by Jerzy Żurawski, 1935-38), which ended in replacement of historic plaster. Despite employing specialists, effects were highly controversial and unsatisfactory because of the poor quality of workmanship or significant differences between the completed work and the state from before the renovation¹⁷.

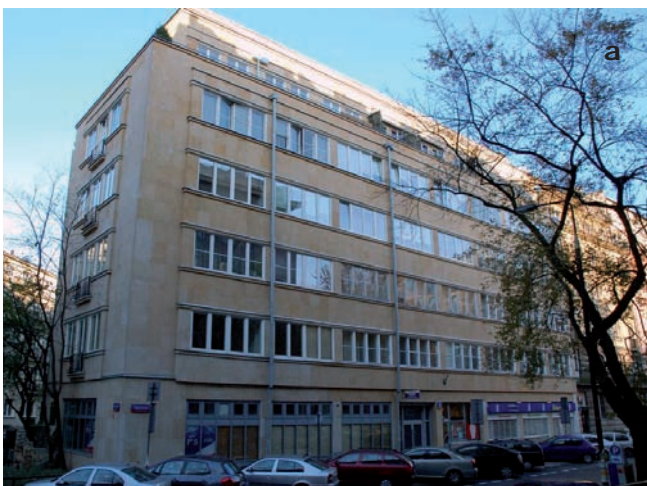
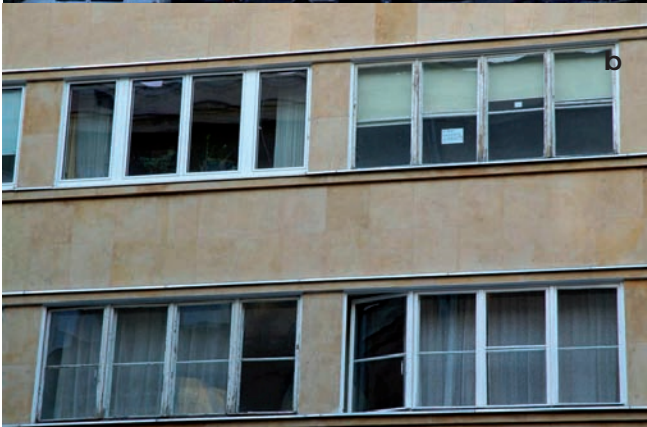
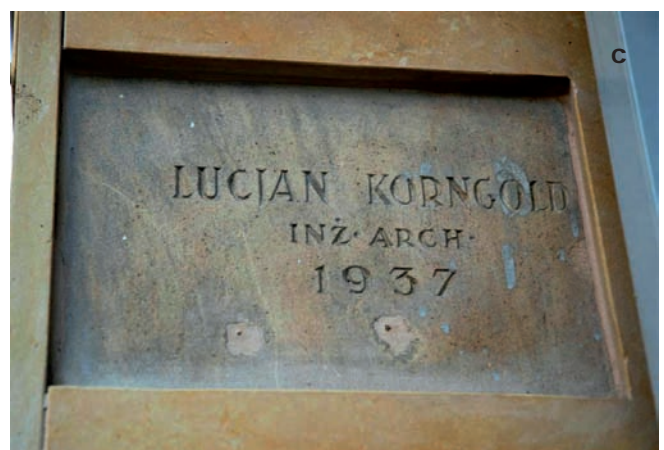
7. Elevation lined with sandstone. Visible slight discoloration, resulting from proper cleaning of the elevation and maintaining it in good condition. Warsaw, O. Robinson's tenement house, corner of 10 Koszykowa St. and Al. Przyjaciół, designed by Lucjan Korngold 1937. **7a.** General view; **7b.** Fragment of elevation; **7c.** Plaque with the architect's name and the original colour scheme re-patinated. Photo by J. Lewicki, 2009

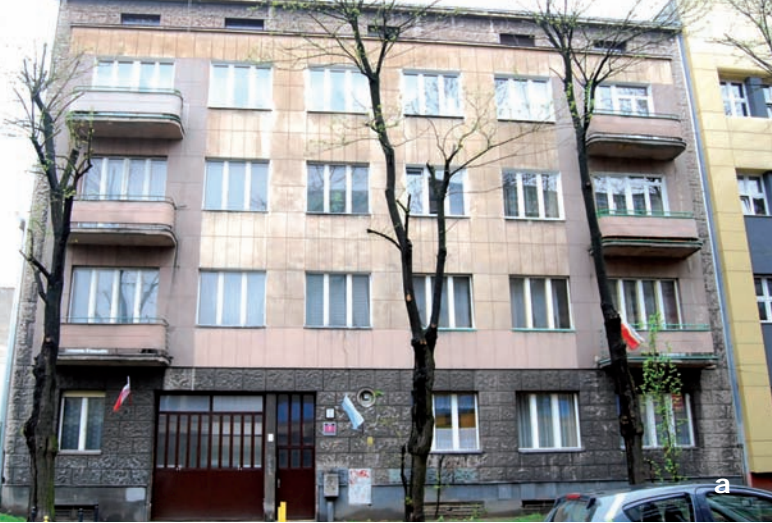
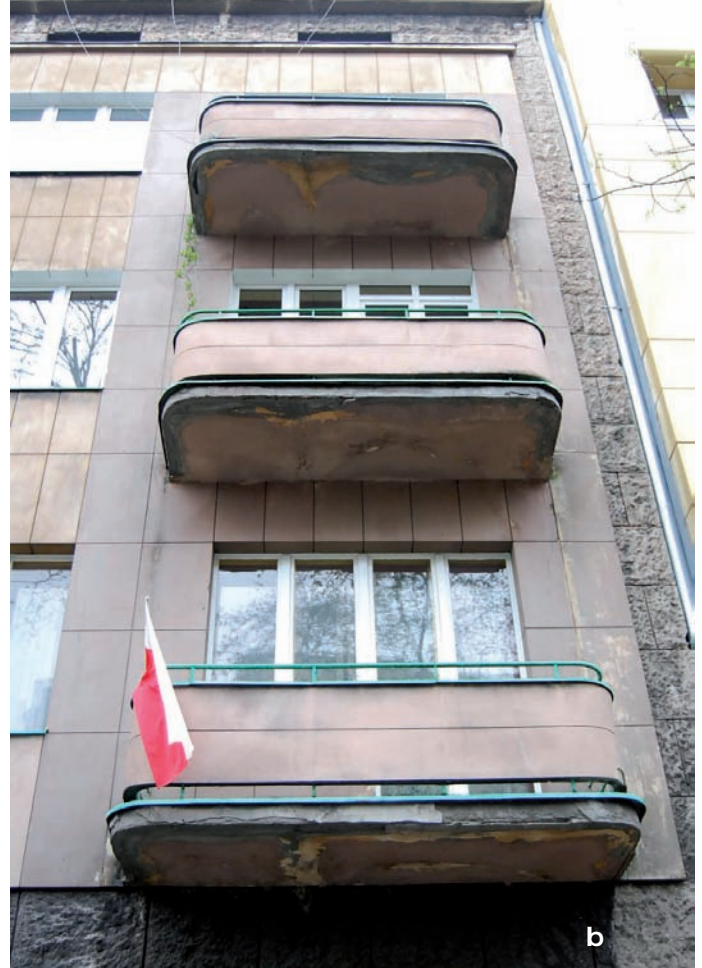
8. Elevation covered with fine plaster, top coat coloured in mass, in the bottom part an addition imitating stone clinker, visible different intensity of colour in the central and side sections of the façade. Łódź, tenement house in Skwerowa St. (now: Polskiej Organizacji Wojskowej 7), designed by the office of "I. Gutman and L. Oli", second half of the 1930s. 8a. General view; 8b. Fragment of elevation. Photo by J. Lewicki, 2010

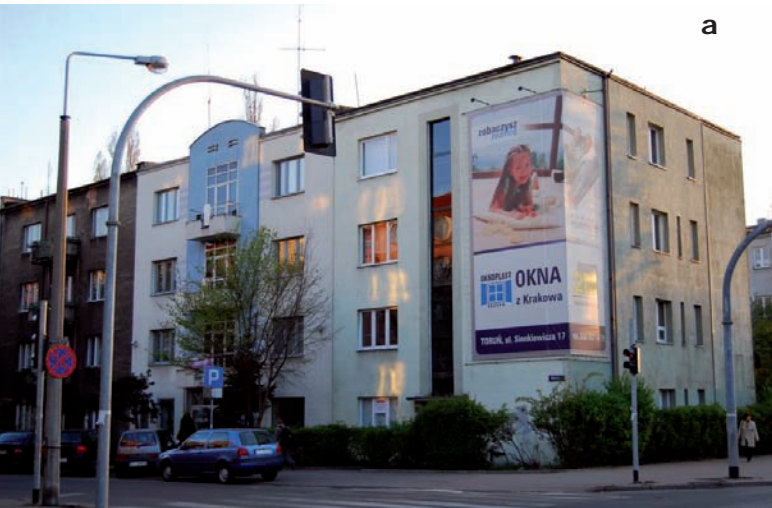
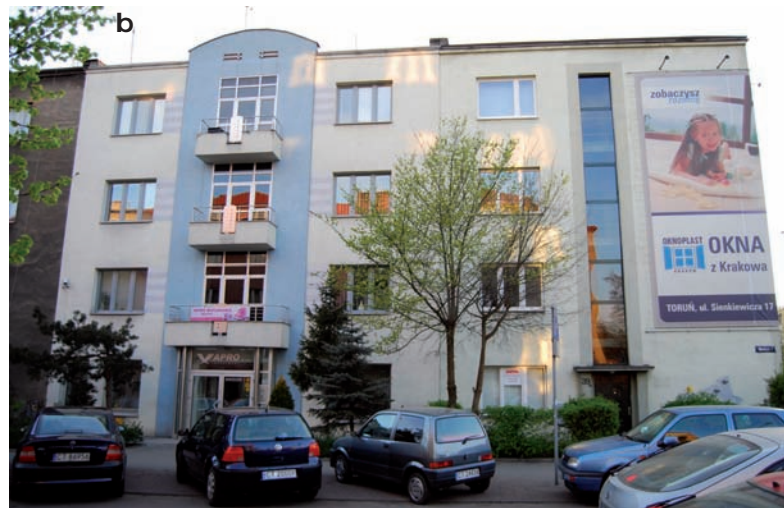
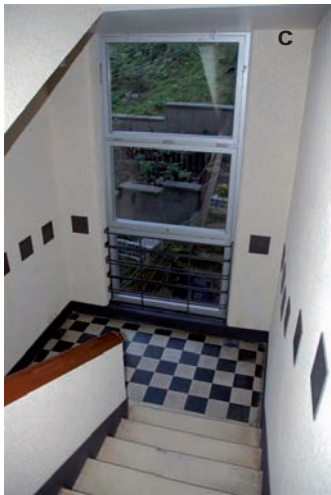
9. Example of destroying architectonic and aesthetic values in an interwar tenement house which was a part of a larger uniform urban complex. Transformation of the building led to destruction and loss of aesthetic value in one building and the whole building complex - Toruń, 39a Moniuszki St., designed in the 1930s. 9a. General view; 9b. Façade; 9c. Stairwell. Photo by J. Lewicki, 2009

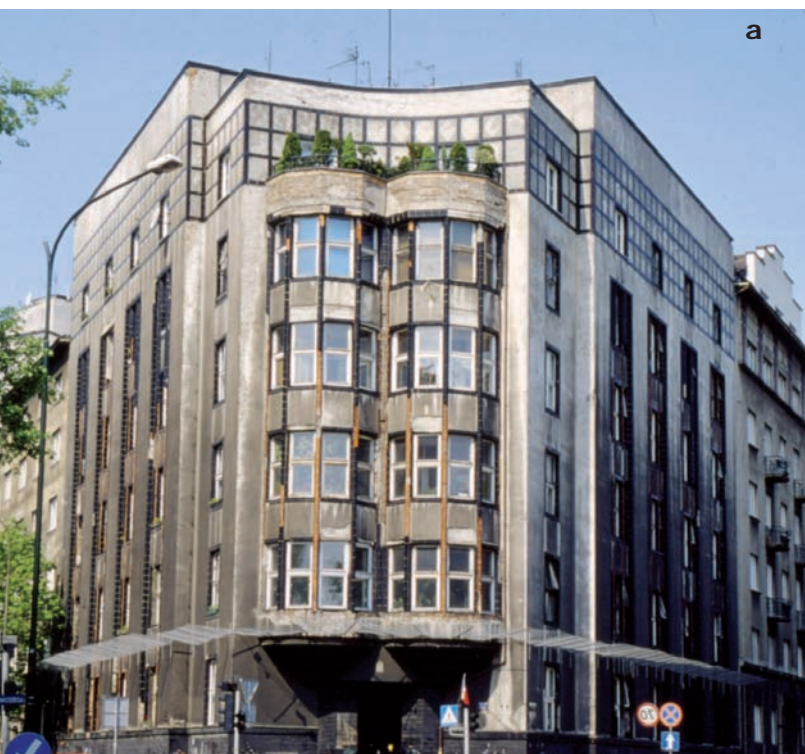
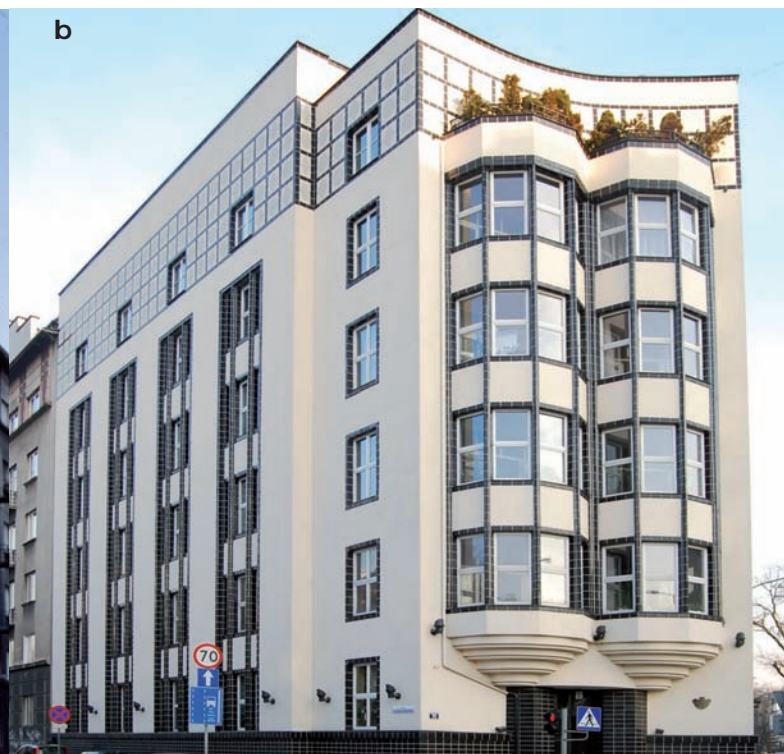
10. Conservation of elevation covered with multi-layer plaster and ceramic clinker facing. Kraków, House of the UJ Professors, the corner of 15 Słowackiego and 61 Łobzowska streets, designed by Ludwik Wojtyczko 1929, realisation until 1932. 10a.-10b. General view. State before and after the work. Photo by J. Lewicki, 2007 and 2010

finishing. Later accumulations were removed, the original light-ochre colour scheme was restored, and the original finishing of joints in the clinker facing was recreated.¹⁵ It was also very important to conserve the ceramic decoration which, originally black, contrasted with the light colouring of the walls. It has marked the beginning of a wider-scale conservation activities concerning conservation of modernist buildings in Kraków.

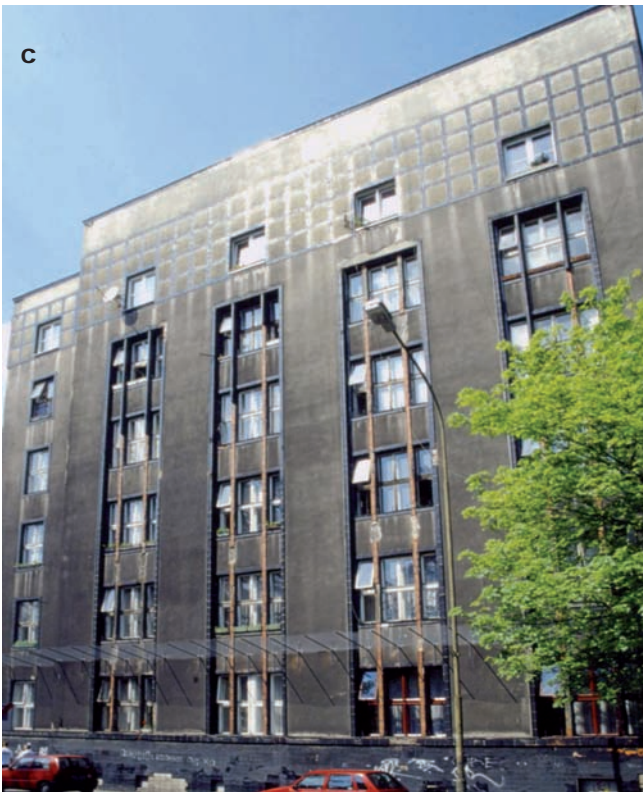
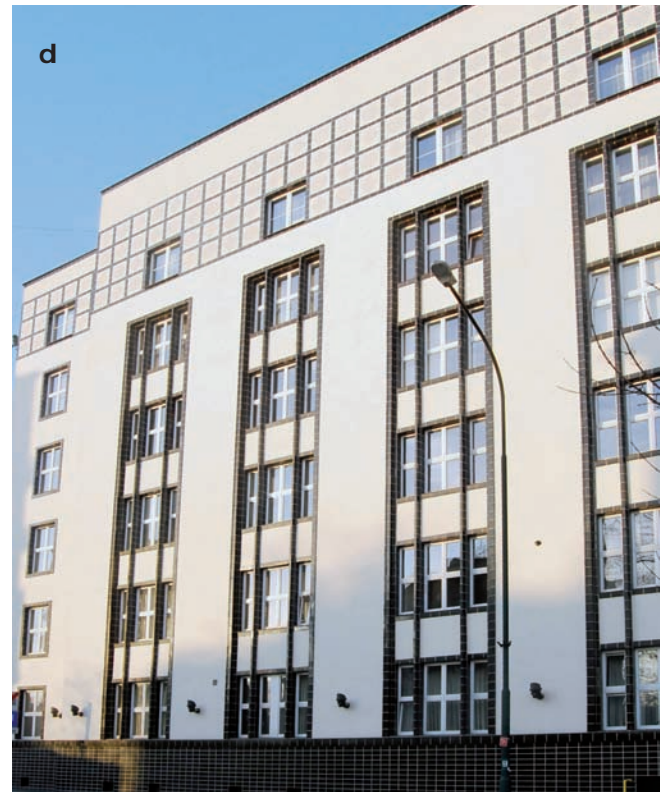
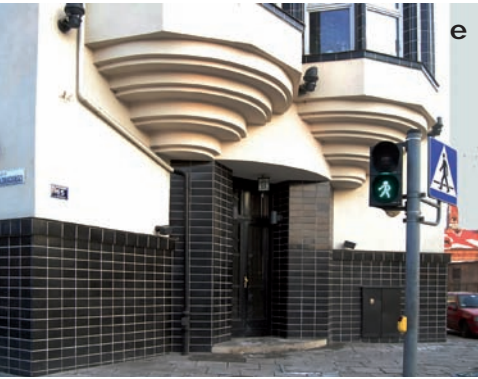
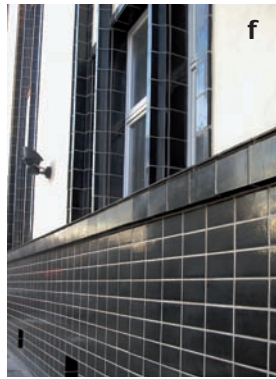
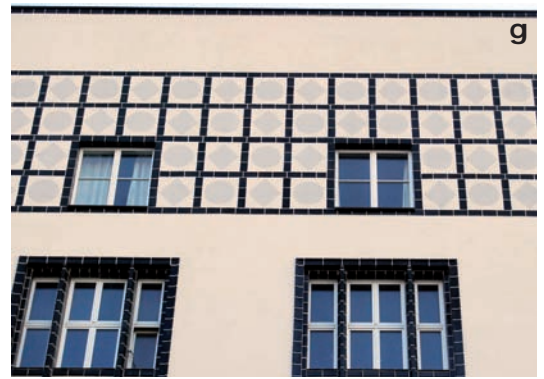
10. Conservation of elevation covered with multi-layer plaster and ceramic clinker facing. Kraków, House of the UJ Professors, the corner of 15 Słowackiego and 61 Łobzowska streets, designed by Ludwik Wojtyczko 1929, realisation until 1932. 10c.-10d. View of side elevation. State before and after the work; 10e.-10g. Fragments of elevation, state after the work. Photo by J. Lewicki, 2007 and 2010
